*Experimenter's Notebook:
Robotic Search for Antarctic
Meteorites 2000 Expedition*

CMU-RI-TR-00-13

Michael D. Wagner
Email: mwagner@ri.cmu.edu

June 2000

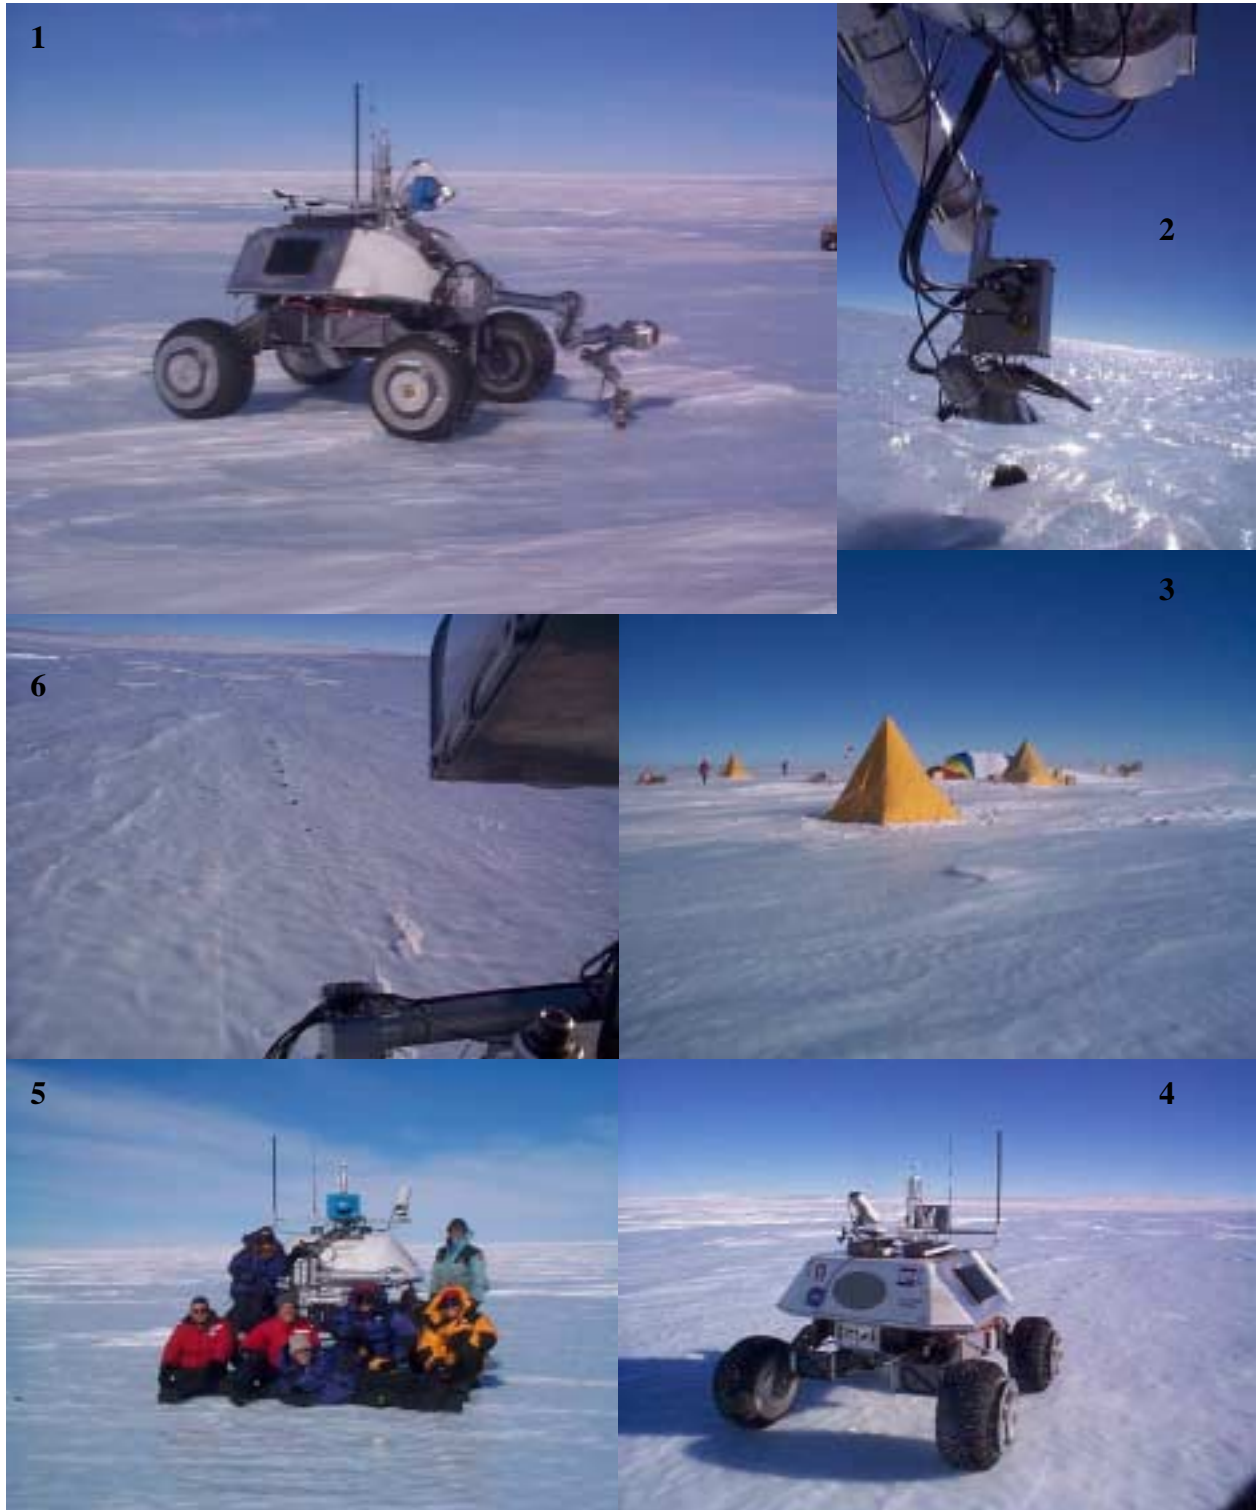
Clockwise from upper left: Nomad's manipulator deployed to a meteorite; a close view of Nomad's wrist examining a meteorite; the Elephant Moraine January 2000 base camp; Nomad in autonomous search mode; the expedition team; the view from Nomad's high-resolution camera

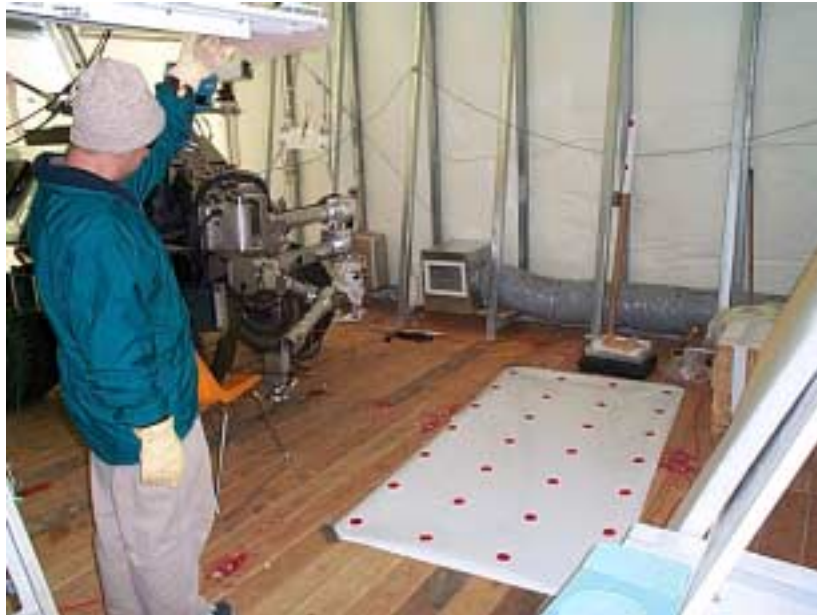
Figure 2. Nomad presented with calibration sheet (in McMurdo Station, Antarctica)

- Calibrate high-res camera with its calibration sheet. This white sheet with red dots is used to calibrate camera parameters such as pan, tilt, roll, focal length, aspect ratios, CCD width and translation from the DGPS sensor to the camera. These parameters are used to make estimates of the location of new science targets found.

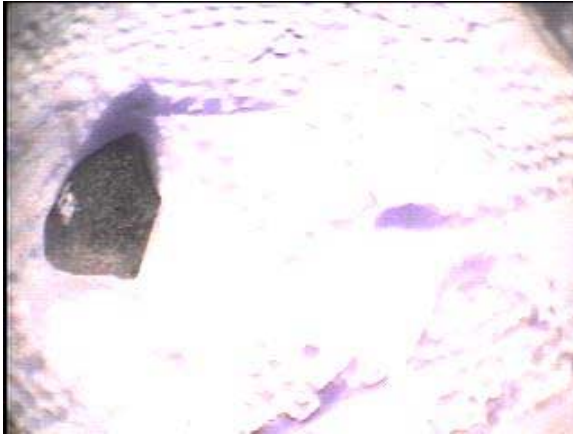
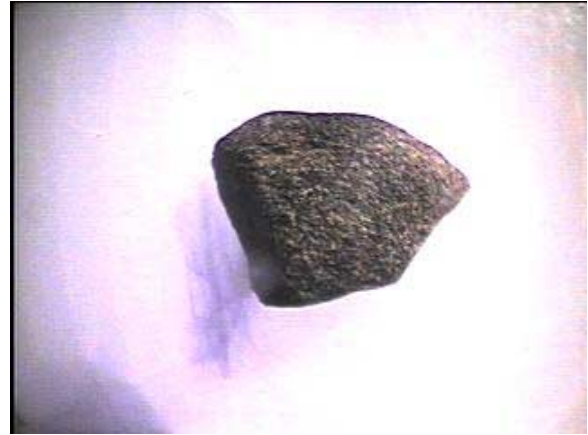
Figure 6. Upper left: initial raw arm camera image when deployed to (0 m, 1.2 m). Upper right: arm camera image from final visual servoing step. Lower right: segmented final arm camera image.

Moved robot onto blue ice without shadows to verify the procedure in the simplest case (segmentation has always worked better on blue ice than snow). Deployed to the same rock, again with an initial estimate of (0 m, 1.2 m). Found the rock centered in the 2nd step, so triggered "already centered" code and immediately moved the wrist down on it.

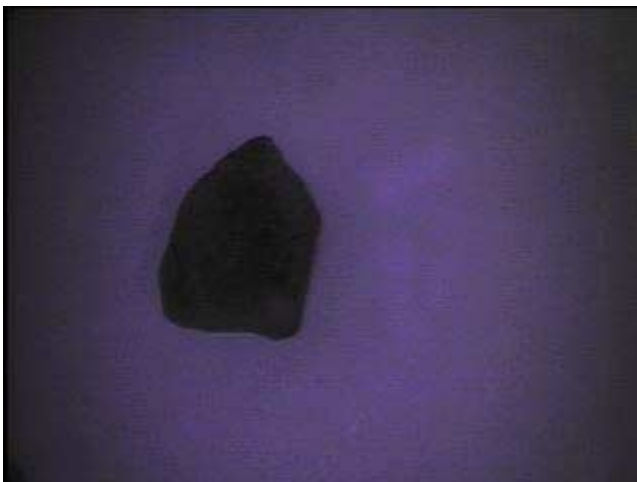
Figure 7. Final arm camera image when deployed to (-0.8 m, 1.3 m)

Next, moved the robot into shadowed blue ice (the robot was casting the shadow in front of itself). Deployed to a rock with an initial estimate of (-0.6 m, 1 m). Rock was on shadow boundary. The visual servoing steps were executed as follows:

1. Target @ row = 58, col = 100. Appears to have picked the real rock target out of a total of 5 segmented (false) targets.
2. Target @ row = 80, col = 140. Looks good. Found a total of 3 targets.
3. Found 1 target, which was the correct one. A little bit of shadow around the corners.
4. Found 3 targets. Target chosen is at row = 166, col = 251. Looks good.
5. Good segmentation.

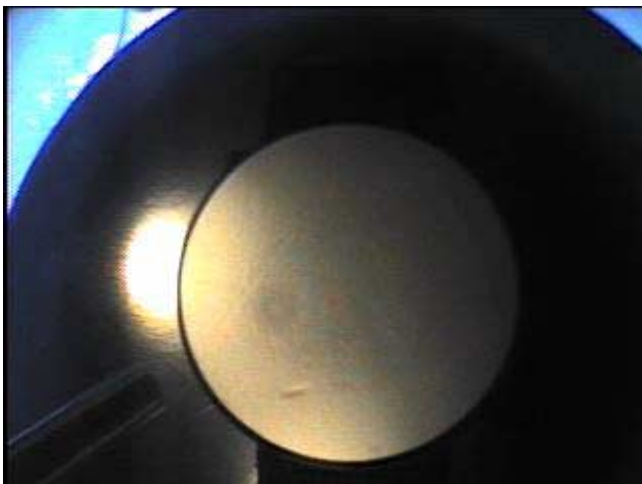
Figure 9. Spectrometer calibration target seen from arm camera

camera sees something like the image in Figure 9. Notice the spectrometer head jutting out of the lower left corner of the image.

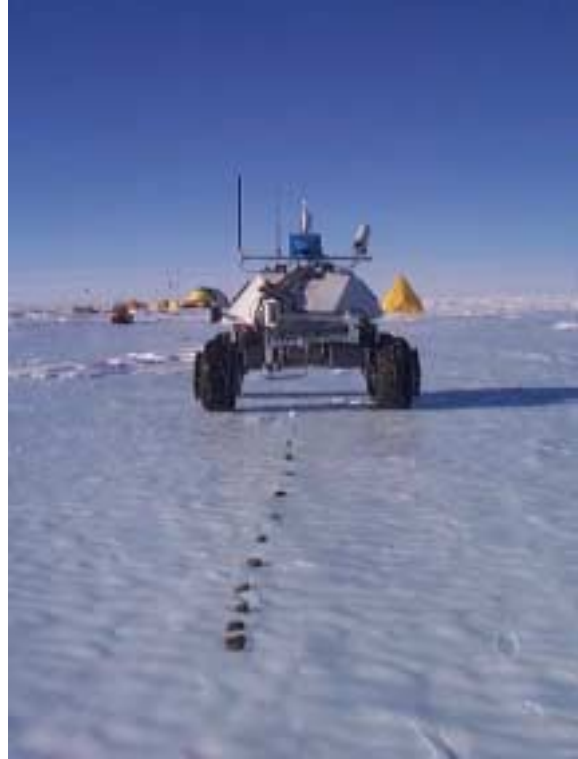
Figure 11. Nomad driving along surveyed line of rocks

The robot did a search along a DGPS-surveyed line of rocks (see Figure 11). In addition to simply acquiring the targets, it also ran the mission planner and sensor manager, so sensors would be deployed.

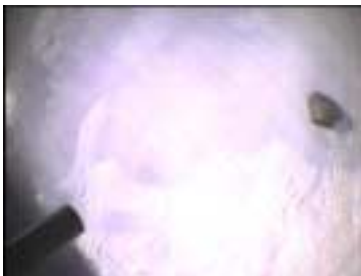
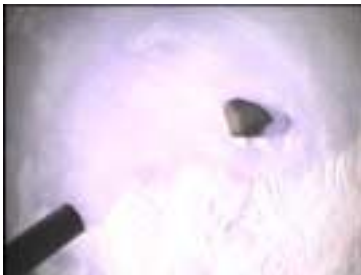
Figure 12. Images from visual servoing attempt 2

Changed *armCamMaxCol* to 300 in *SAS_Config*. However this attempt failed after the second step when it tried to move down. At the time we were not sure of what caused the failure:

From the images in Figure 12, it can be seen that the rock was not segmented well on the first step. Additionally, shadows caused the spectrometer's centroid to shift over. These two things resulted in the spectrometer's centroid being closer to the center of the image than the rock, so the spectrometer was chosen as the target for step 1. This will always disrupt visual servoing.

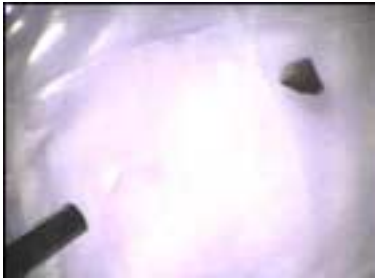
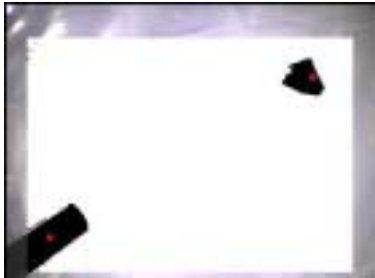
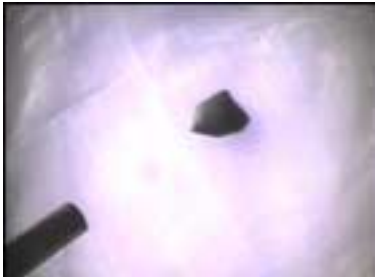
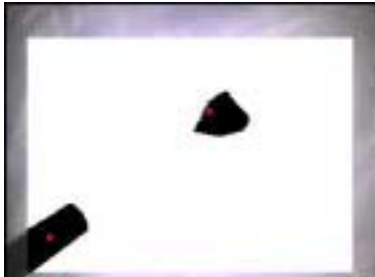
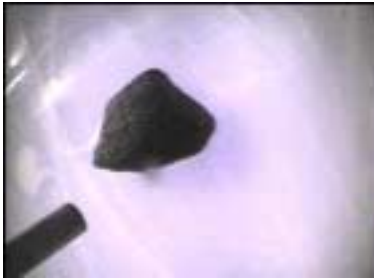
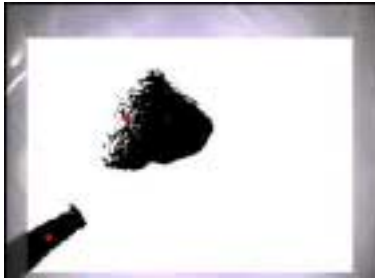
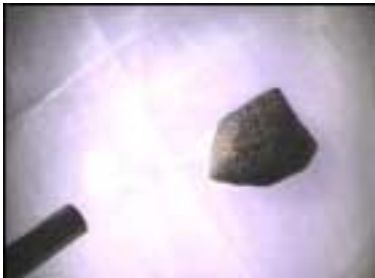
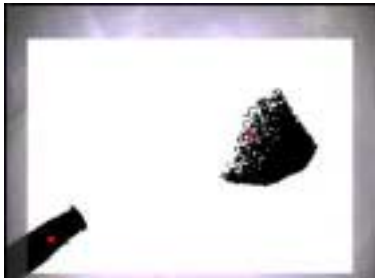
Figure 13. Images from visual servoing attempt 3

This time the rock was moved to approximately (-1 m, 1 m). This time visual servoing succeeded without any problems. See Figure 13 for images from the steps.

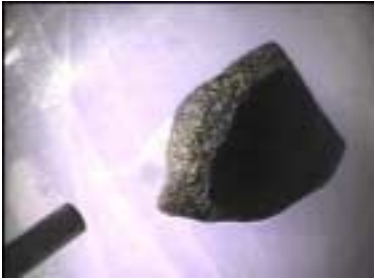
It seems a trend that as the wrist moves down and the rock gets bigger in the image, shadow compensation is probably performed, which causes the spectrometer to be segmented less properly. However, the results seem good for the spectrometer in this location.

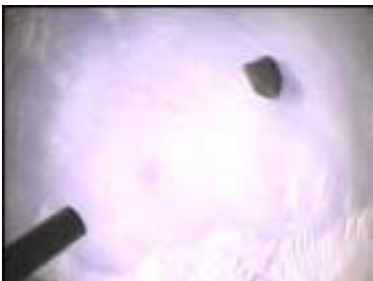
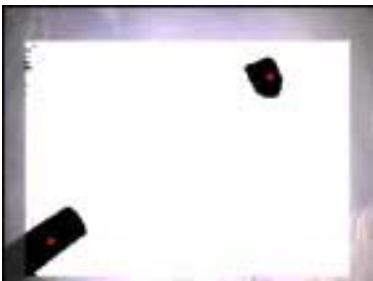
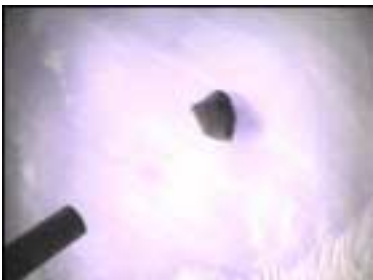
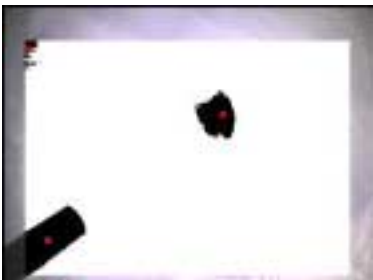
Not available
Figure 14. Images from visual servoing attempt 4

The time the rock was moved back to (0 m, 1.2 m). But again, visual servoing failed on the downward step. See Figure 14.

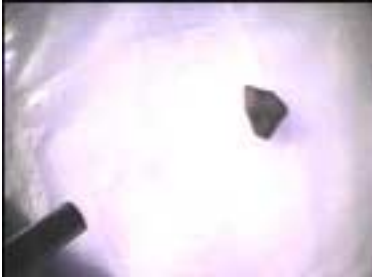
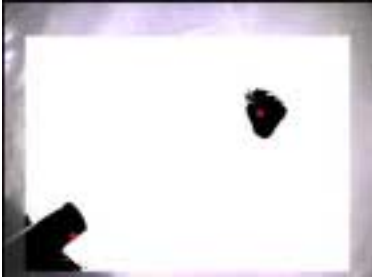
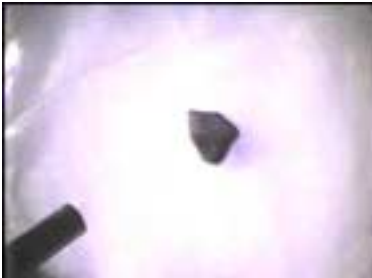
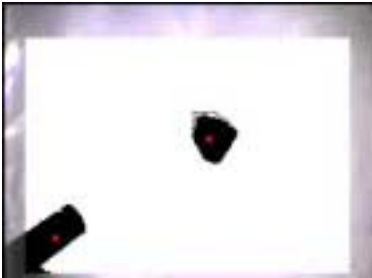
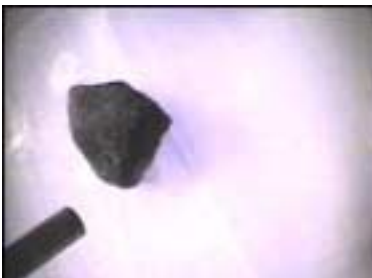
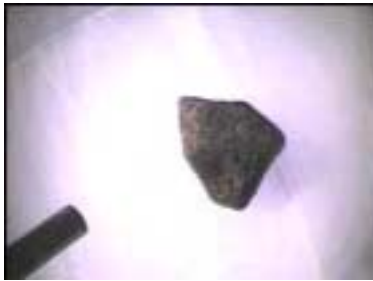
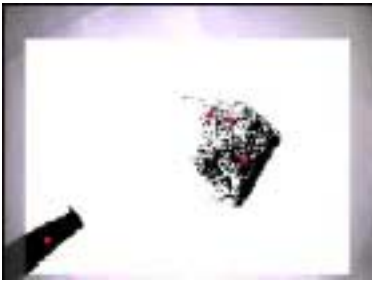
Again, the same rock was used, placed approximately at (-1 m, 1 m).

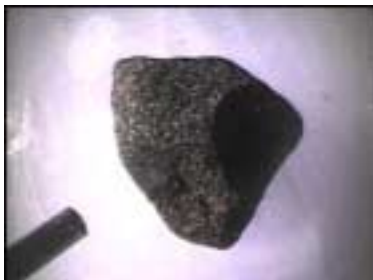
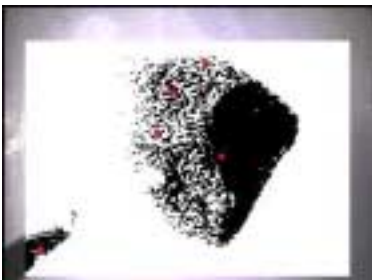
Figure 15. Images from visual servoing attempt 5

This was a successful visual servoing attempt, as seen in Figure 15. Again note how the rock and spectrometer are broken up during segmentation. This may be due to shadow compensation.

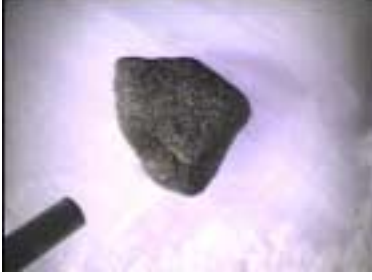
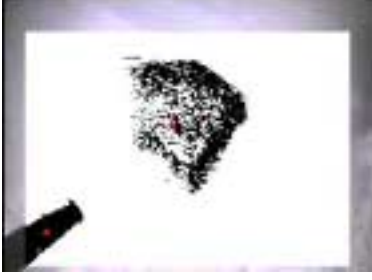
Figure 16. Images from visual servoing attempt 6

We placed the rock at (0 m, 1 m), the same location as attempt 1. Attempt 1 failed, but attempt 6 did not. The images are shown in Figure 16.

Notice that in step 3 the rock is adjacent to the spectrometer. However, this caused the centroid of to shift enough not to ignore it. This supported our *armCamSpec** parameter changes before attempt 5 -- they ignored enough of the image to generally remove the spectrometer, but not too much to find a rock adjacent to the spectrometer. Overall the results supported the code changes

made to eliminate the spectrometer from a list of segmented targets.

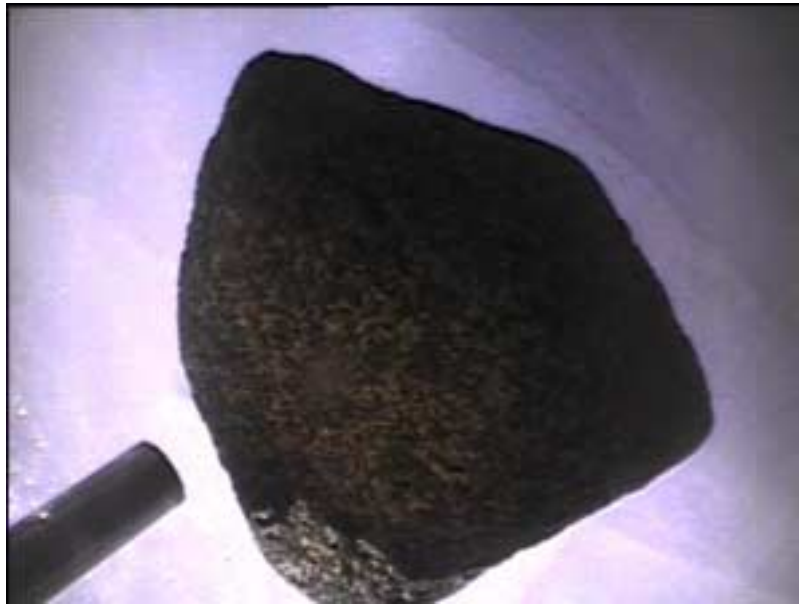
Figure 17. Top: reflectance spectrum of ID #0 (spectrometer head > 2 cm from rock), bottom: arm camera image as spectrum was being taken

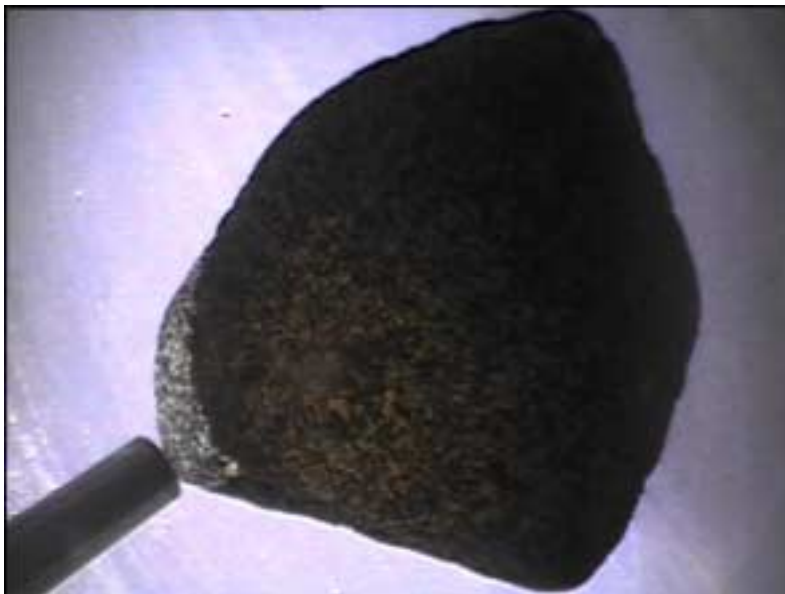
Figure 18. Top: reflectance spectrum from ID #1 (spectrometer head 1 to 1.5 cm from rock), bottom: arm camera image as spectrum was being taken

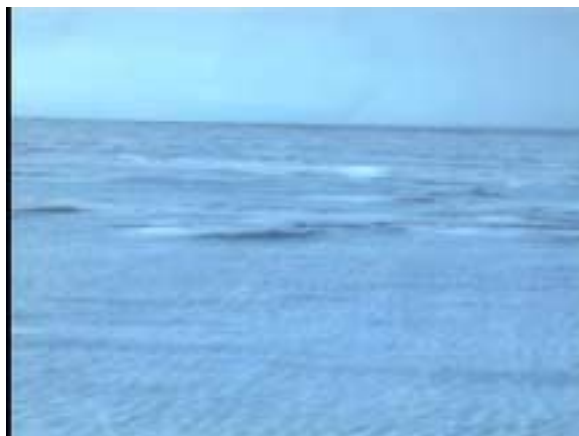
12:09 pm: Image from high-res camera while Nomad traversed. Pan and tilt angles are at 0 degrees, and the lens is fully zoomed out.

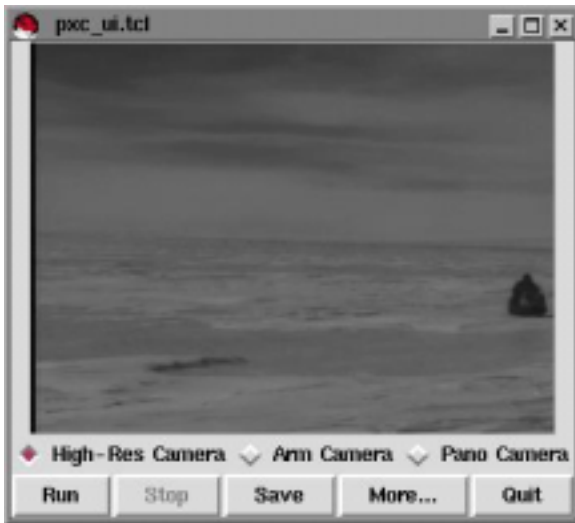
12:48 pm: Screen shot of Nomad's teleoperation interface. It displayed live images from any of Nomad's three cameras at rates from 0.3 to 0.5 Hz, even when the robot was 1.2 km away. Images are in grayscale to reduce bandwidth. In this screen shot, a high-resolution image shows a skidoo following along side Nomad.

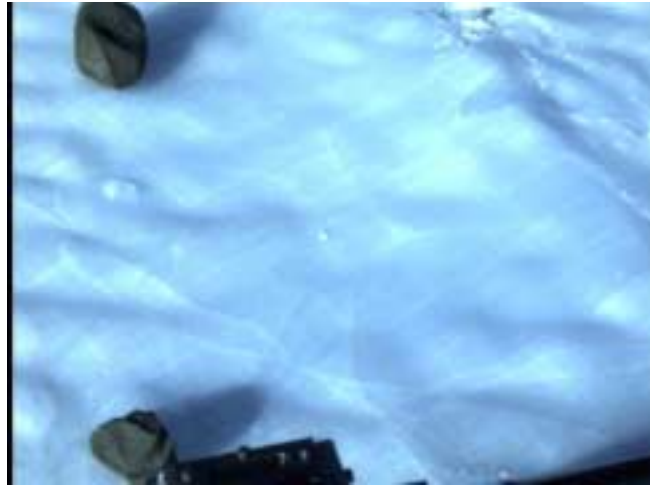
Figure 24. Two rocks on blue ice

Took an image of two larger rocks on blue ice with the high-res camera in target acquisition position (see Figure 24).

The top rock fits in a box of 83 x 87 pixels. This is a total size of 7221 pixels. The bottom rock fits in a box of 97 x 76 pixels. This is a total size of 7372 pixels. The variable *targetAcqTopMaxPix* was therefore set to 7200 pixels while *targetAcqBottomMaxPix* was set to 7300 pixels.

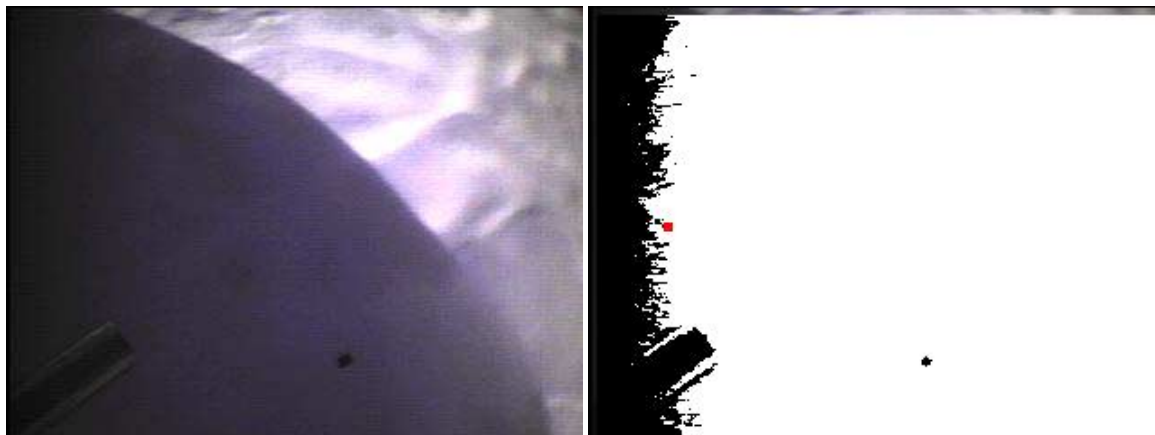
Visual servoing failed for the fifth target found (ID 4) failed because the rock was very small and shadowed. Figure 25 shows the initial step, where it failed.

Note that visual servoing did not stop to ask for manual intervention because the shadows were segmented as a target. However, this shows how small a rock could be found.

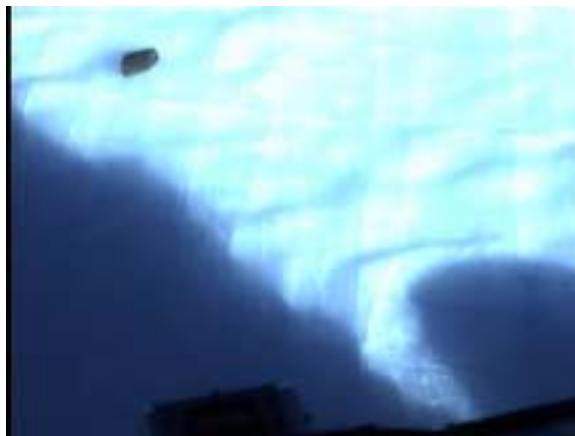
Figure 26. Rocks on blue ice with sun behind Nomad

In Figure 26, the robot's shadow is cast into the area of target acquisition. This causes the shadow compensation routines to run, which causes darker pixels to be ignored. In this case, the rock in the upper left corner of the image was ignored. Furthermore, so many shadows cause the auto-iris to open up, making ice look even brighter than usual.

Two test runs were performed in which the robot is driven along a straight line with target acquisition running. When the robot drove in the same direction in which the pattern had been executed, shadows were common (the sun was behind the robot) and often caused segmentation to fail.

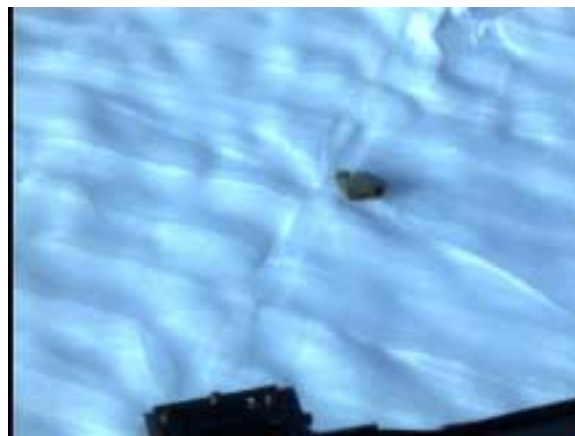
Figure 27. Rock on blue ice without shadows

In Figure 27, notice that now the shadows are not seen, and the ice looks a bit less overexposed. However, the rock in this picture was segmented into three distinct targets.

The conclusions from this test were that the pattern should be performed in this new direction perpendicular to the sun's rays, and that it would be good to add code that would combine multiple targets whose DGPS estimates are very close together.

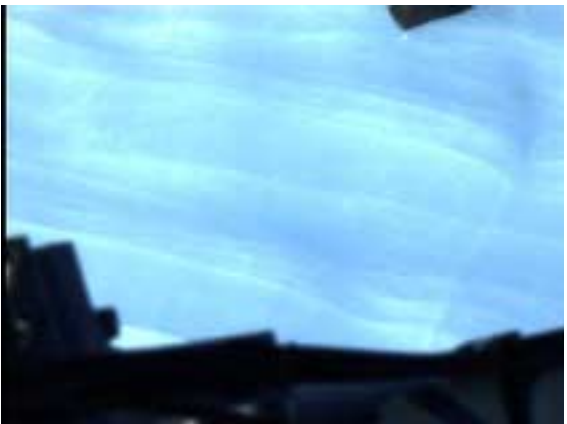
(ID 3), the high-resolution camera servoing seemed to be working well, but in the last step, the arm ended up in the image. The visual servoing steps are shown in Figure 28. Notice that in the first image, the rock is just barely visible at the bottom -- this is probably due to a very bad DGPS estimate.

<p>Although it wasn't even in the last image, the arm gets chosen as the final target</p>
<p>Figure 28. Images from servoing the high-resolution camera to ID #3</p>

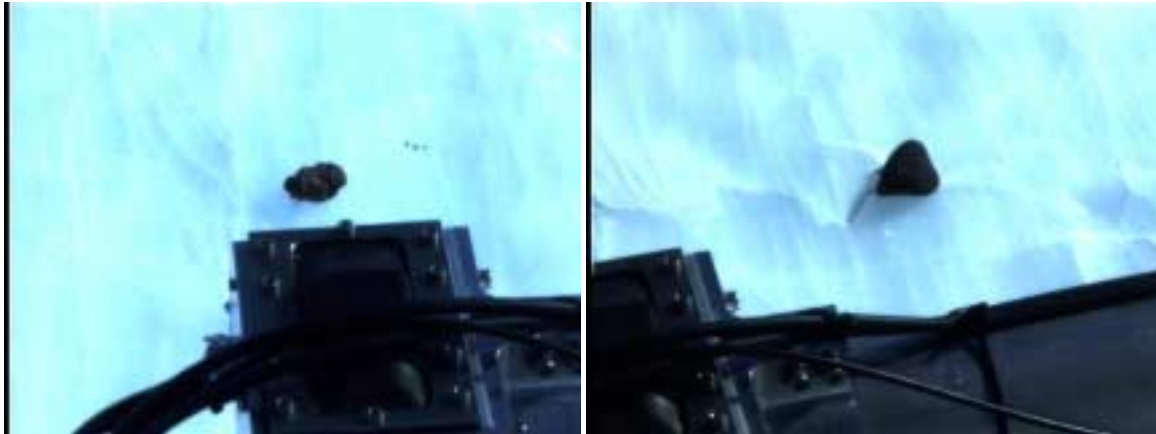
For IDs 4 and 6, too many targets were found when deploying the high-res camera, so these targets were subsequently ignored. However, there is clearly only one rock in each image. The images are shown in Figure 29.

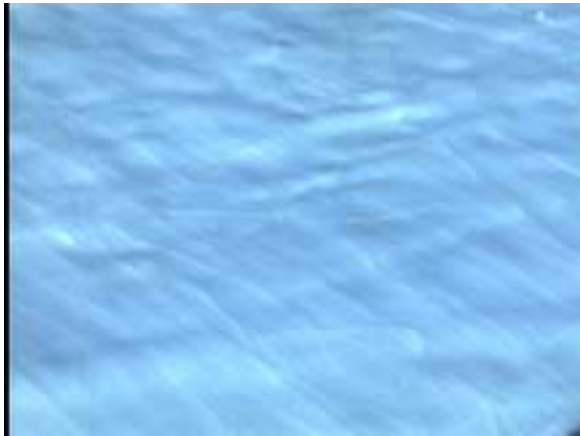
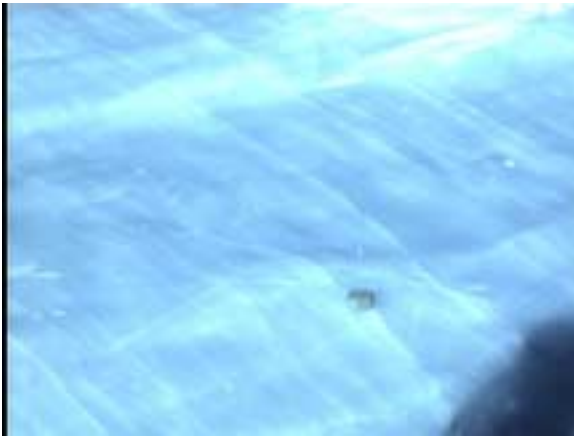
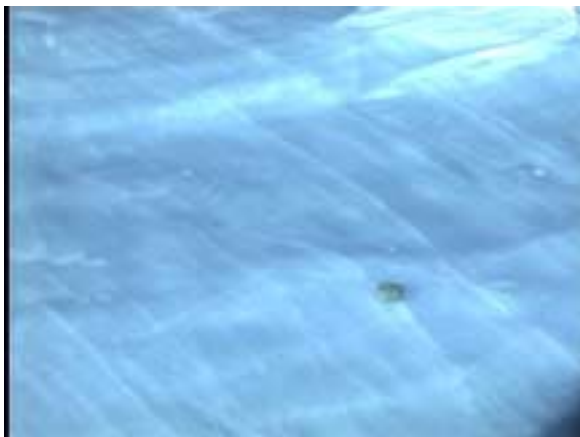
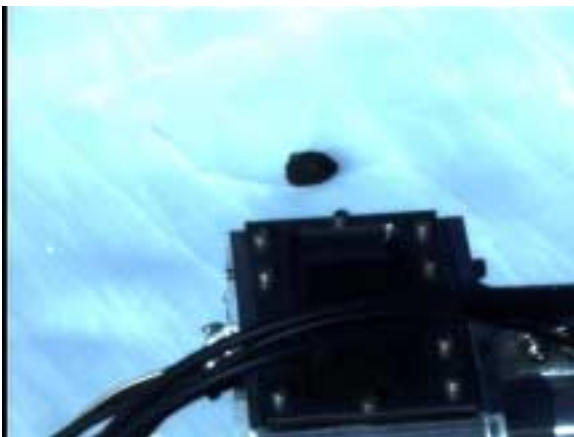
Figure 30. High-resolution camera images that resulted in failures

There were some problems with throwing out real rock targets. In particular, IDs 16 through 19 were troublesome. Figure 30 shows the images that caused the high-res camera software to fail for each of these. IDs 17 and 18 were known as “Rock E” which was a very white rock that was easily missed by the target acquisition segmentation method.

ID #16 (rock D) -- found no targets

ID #17 (rock E) -- found no targets

ID #18 (rock E) -- found no targets

ID #19 -- found too many targets

ID #20 -- found too many targets

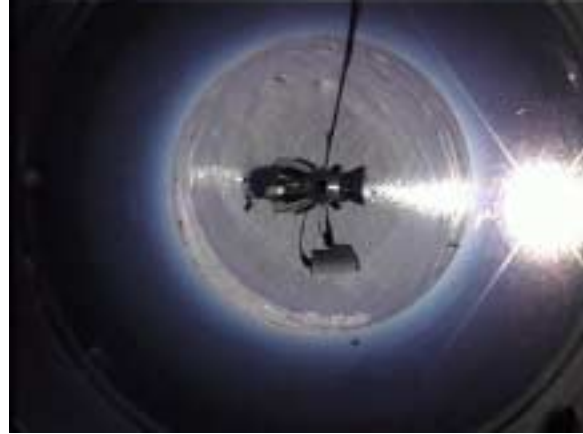
Figure 31. Panoramic image taken during traverse into the moraine

Before the day's operations, Nomad drove into the moraine for its final demonstrations. The destination area of the moraine is over 1.1 km away, almost due west of camp. The moraine is mostly sastrugi and packed snow rather than blue ice. The rocks are much denser than the blue ice as well. Finally, unlike the blue ice, the rocks here are much more likely to be terrestrial. Figure 31 shows a panoramic image taken along the trip.

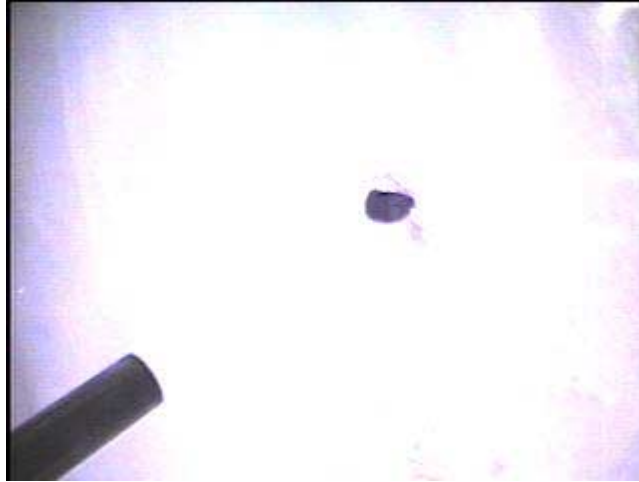
Figure 32. Arm camera image from failed visual servoing attempt

Visual servoing in general did quite well, occasionally failing only because of questionable segmentation. There were no cases of failure after 2 attempts. Three attempts required manual intervention when no rocks were found. Figure 32 shows one case where segmentation failed, on ID 3. Notice how washed out the image is.

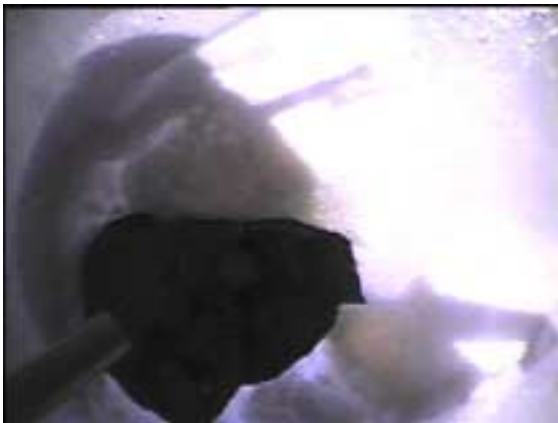
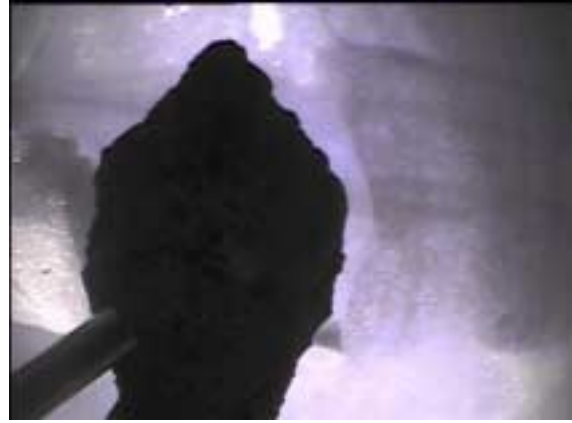
Figure 33. Arm camera images from left: meteorite 12387, meteorite 12322

Figure 33 shows some arm camera images of the meteorites studied in this activity.

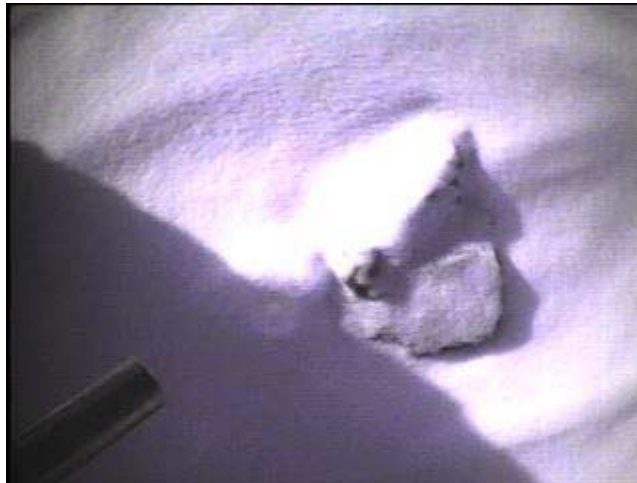
Figure 34. Snow covered rock in the moraine, as seen by Nomad's arm camera

The demo took place in the moraine. The pattern's rows were 200 m long and proceeded to the left. Many rocks were partially covered with freshly fallen snow. Additionally, in the moraine the size of rocks varies dramatically, from 1 to 50 cm. Some larger rocks that were snow covered appeared as a few unconnected rock regions, so Nomad reasonably considered them multiple targets (see Figure 34).
