Integrated Collision Warning System
Final Evaluation Report (May 2006)
FTA-PA-26-7006-06.1

**Integrated Collision Warning System
Final Evaluation Report**

May 30, 2006

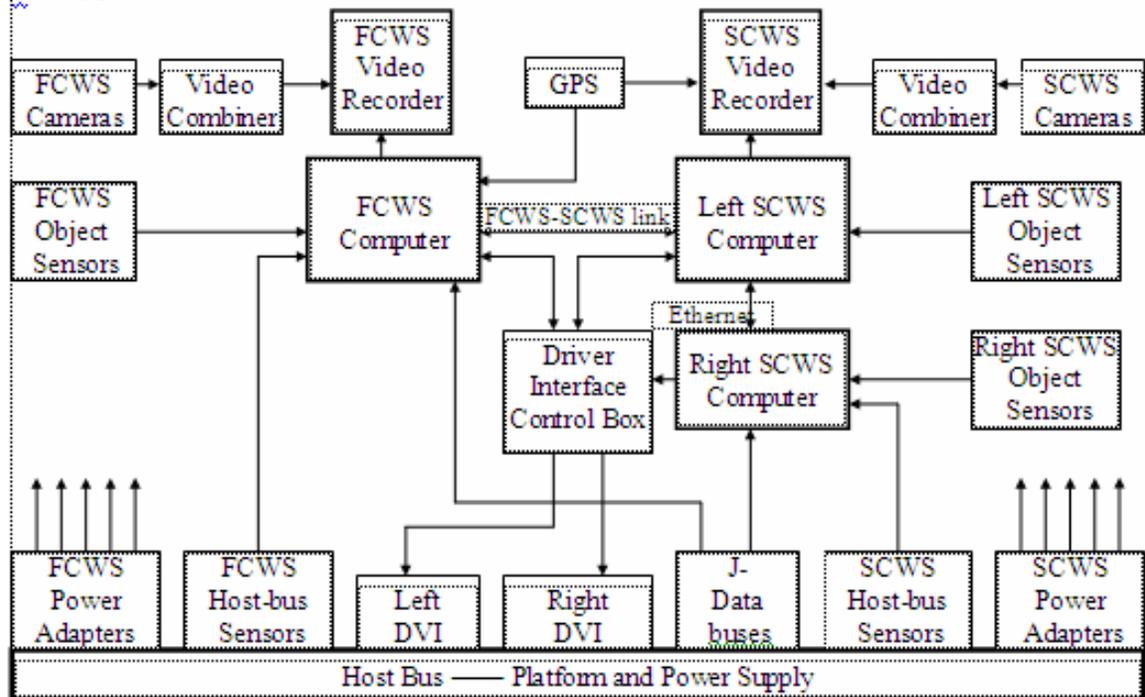
Figure 1-1 shows the architecture of the Integrated Collision Warning System (ICWS) Prototype.

Figure 1-1 - System Architecture

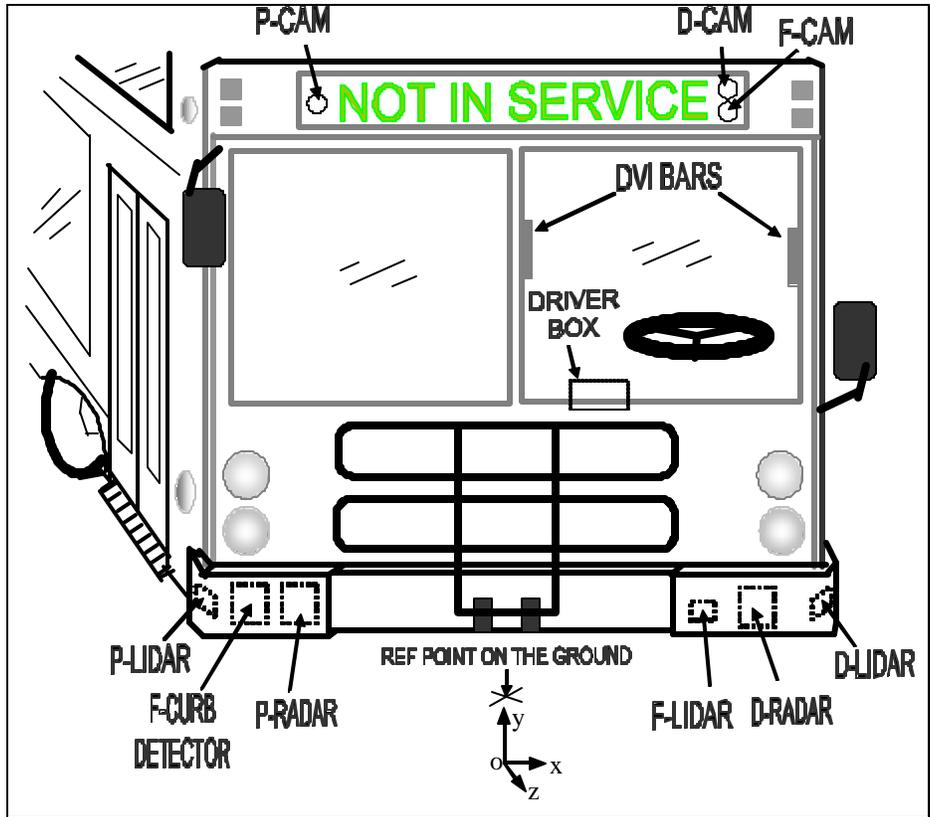
Figure 1-3 - Layout of FCWS sensors, cameras, DVI and SCWS curb detector

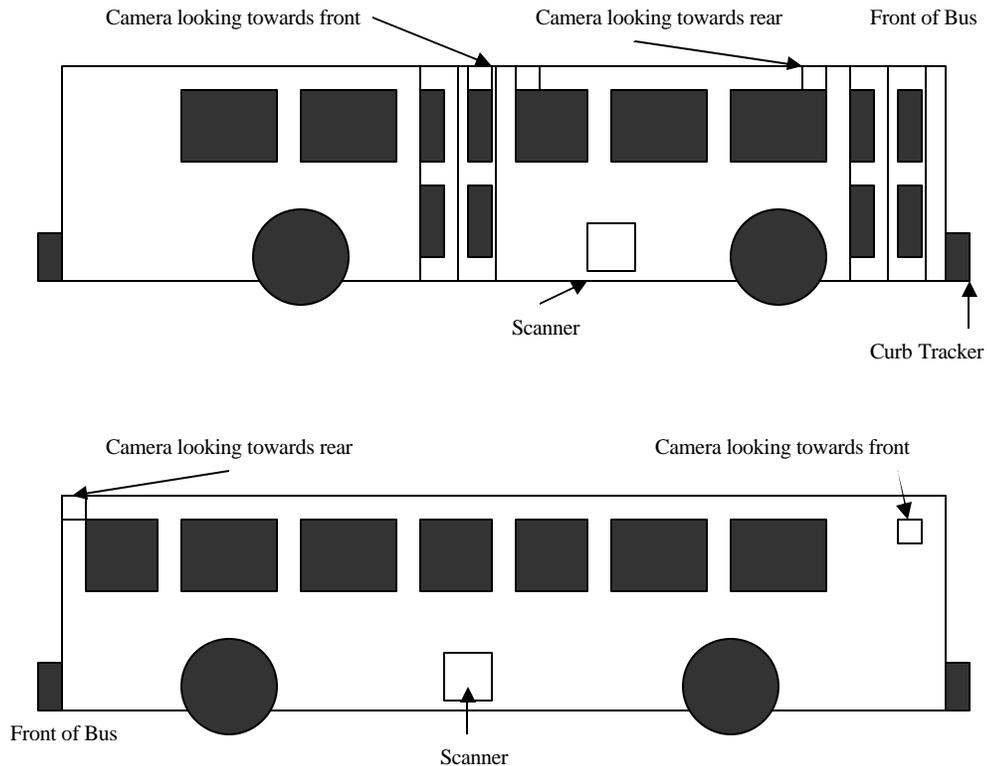
Figure 1-5 - Right and Left Side Collision Warning System Sensor Layout

Figure 1-7 shows the forward part of the left side of SamTrans bus number 601. The data collection camera that looks toward the rear of the bus can be seen in the upper left corner of the figure. There are four of these cameras, whose locations are shown in Figure 1-5.

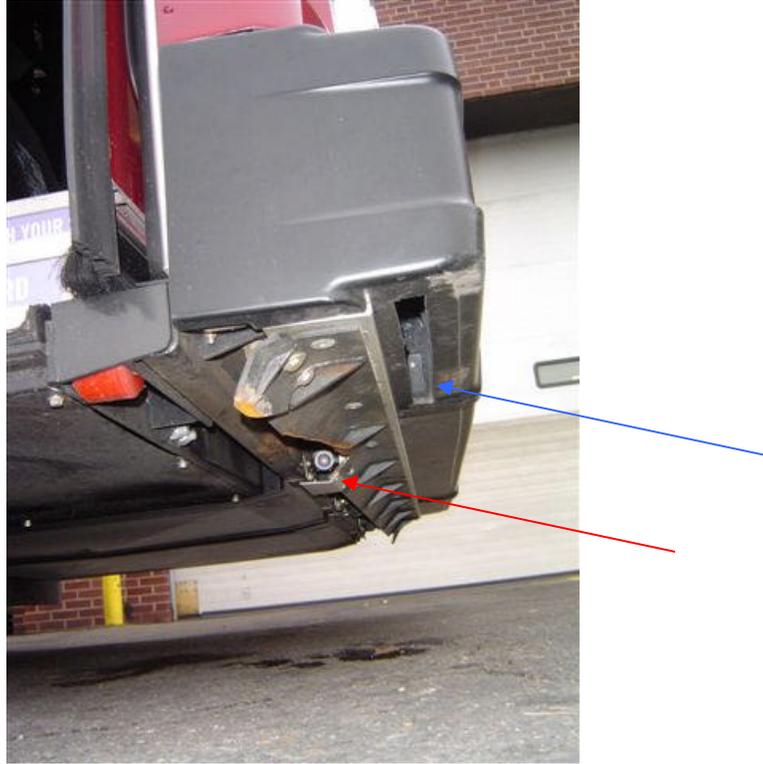
Figure 1-6 - Front bumper with the laser (blue arrow) and camera (red arrow) visible

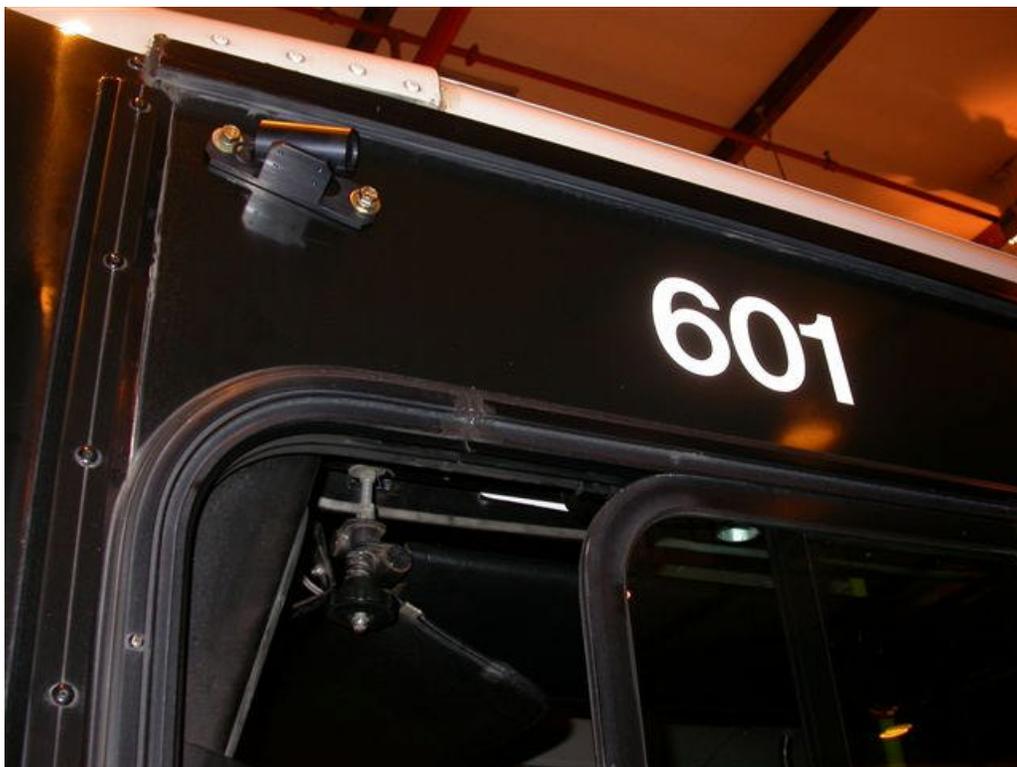
Figure 1-7 - Left Side Camera on SamTrans Bus 601

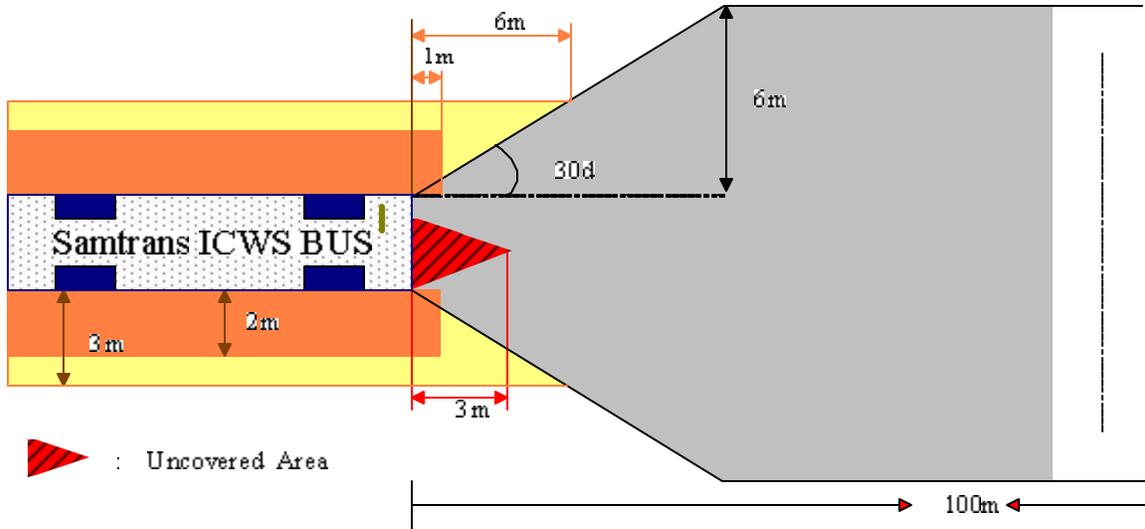
Figure 1-9 and Figure 1-10 illustrate the Fields of View of the two buses equipped with the ICWS system. The farthest detectable range for the FCWS in the same lane is 100 m (330 ft) and the closest detectable range in the same lane is no greater than 3 m (10 ft). The maximum detectable side-looking angle from the front bus corners is 30 degrees on SamTrans bus 601 and 20 degrees on the PAT bus. The detectable lateral position for the forward sensors is over 6 m (20 ft). The side looking sensors can closely track objects that are within 3 meters of the bus however, objects can be detected as far as 50 meters away.

Figure 1-9 - Integrated system s patial coverage on SamTrans bus

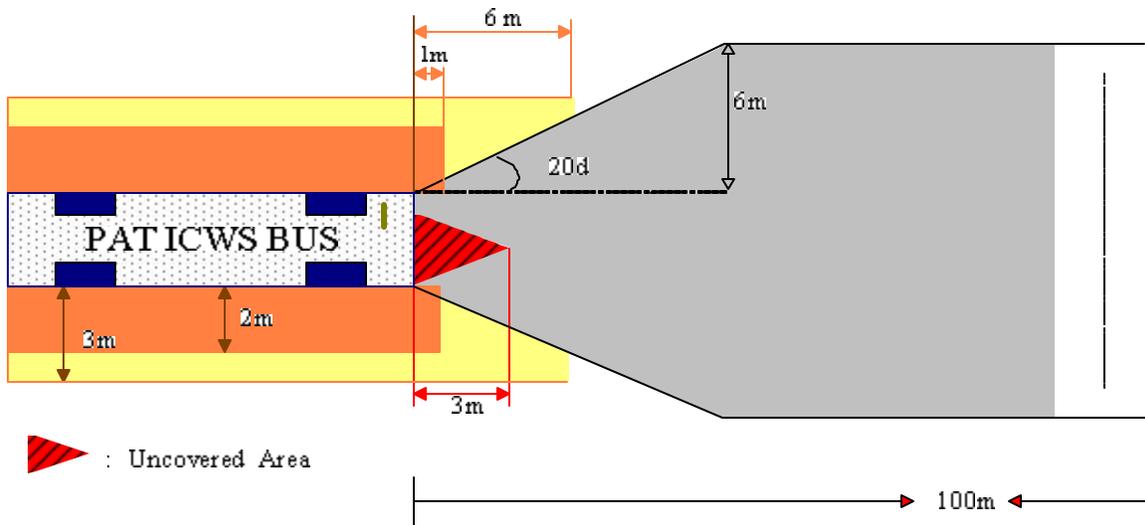
Figure 1-10 - Integrated system s patial coverage on the PAT bus

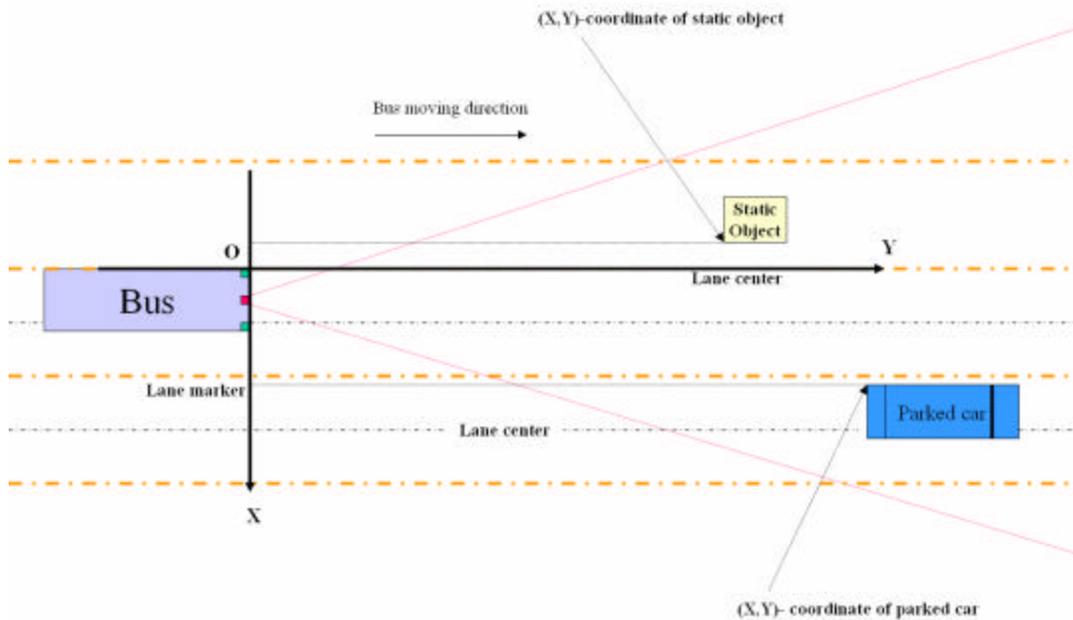
Figure 2-1 - Bus is driven along the left lane marker instead of the lane center

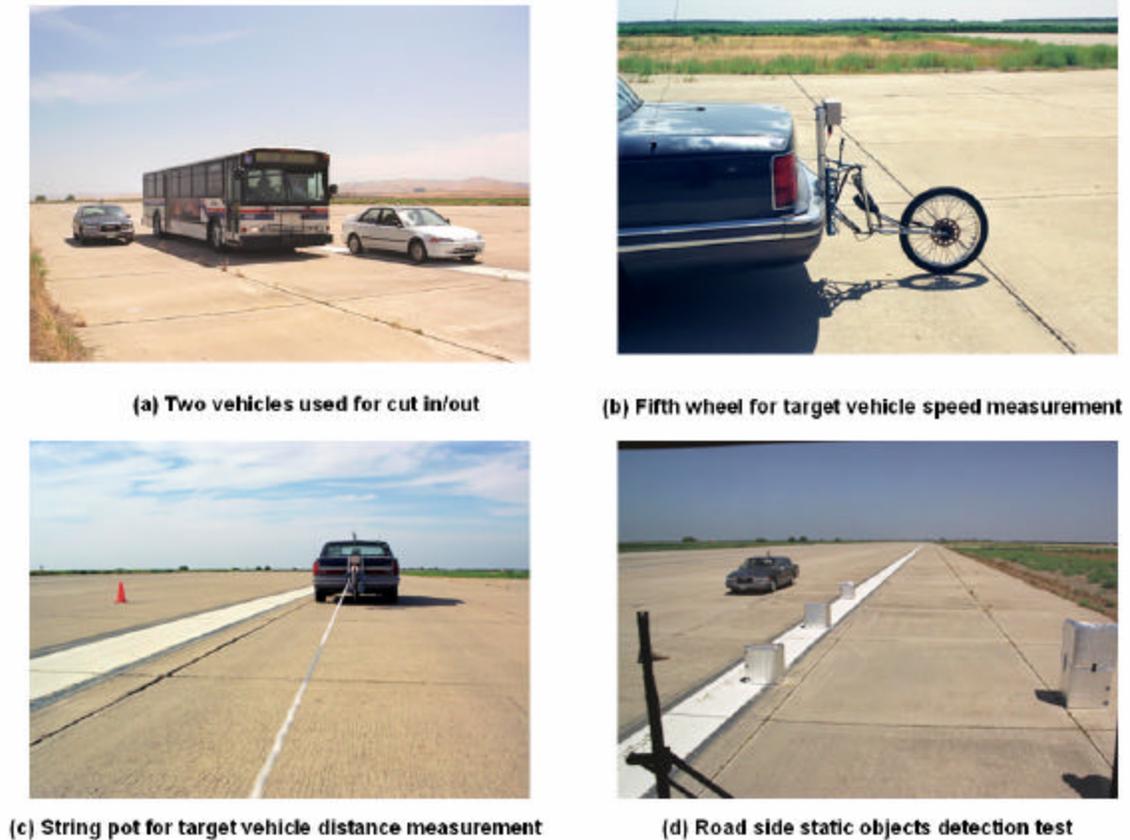
Figure 2-2 shows the instrumented target vehicle and static target placements. The placement of the static obstacles and the instrumentation provide means for collecting independent and ground truth data regarding range, range rate and lateral displacement of the obstacles. This information is compared with the data collected and processed within the FCWS to independently determine the soundness of the warning signals.

Figure 2-2 - Photos of the test instrumentation and setups

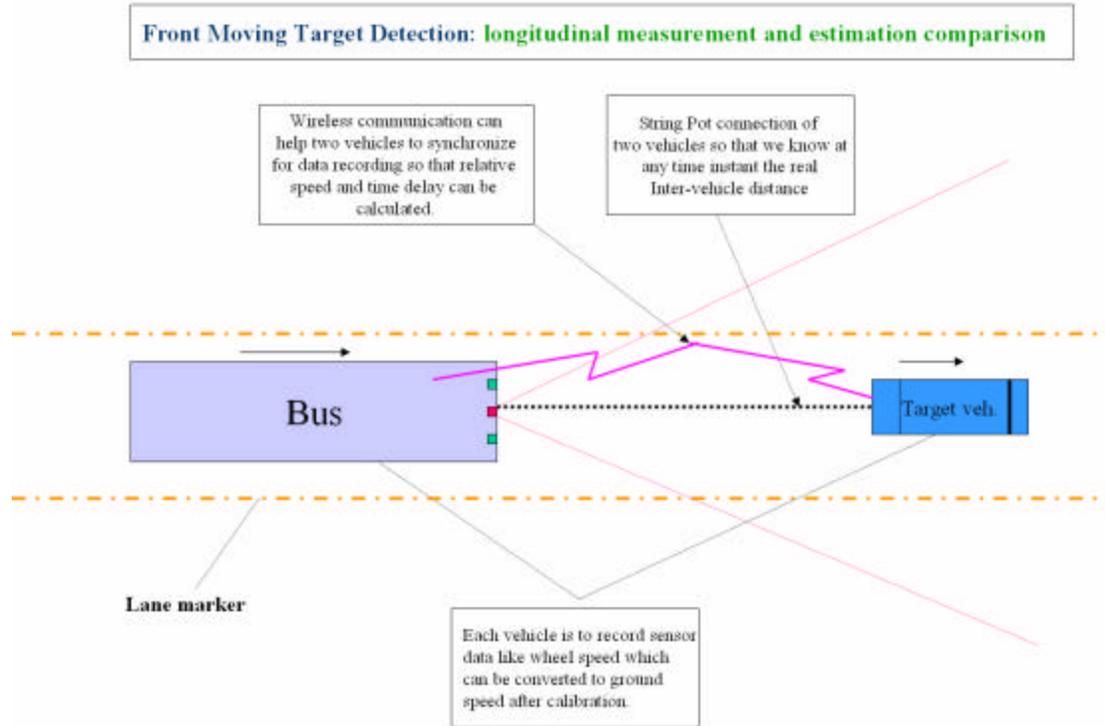
The tests were conducted with the bus following the target vehicle along a straight path defined by reference lines. The target vehicle accelerated to predetermined speeds (5 mph, 10 mph, 15 mph, 20 mph) for a short duration and then decelerated at approximately 0.2 m/s^2 , 0.5 m/s^2 , or 0.8 m/s^2 . Because the total length of the string was 16 m, the tests were conducted to limit the range variations within 6.4 m in order to avoid breakage. Figure 2-3 depicts the configuration of this set of tests.

Figure 2-3 - Tests for longitudinal measurements wrt a frontal moving target

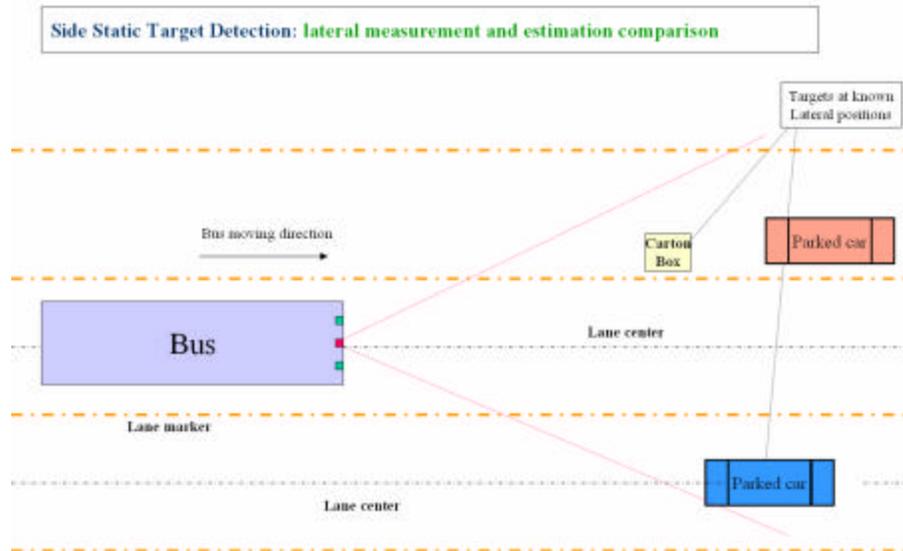
Figure 2-4 - Parked cars on both sides, with all car doors closed

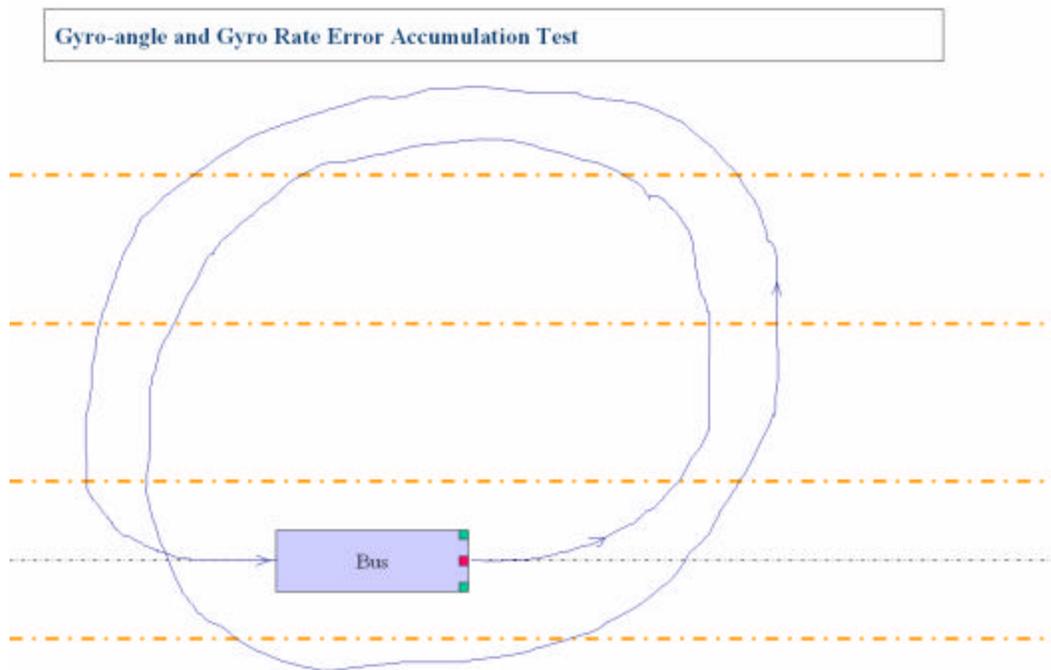
The evaluation tests focused on the error characteristics of the gyroscope, which is typically presented in the form of accumulated error. To test the error accumulation, the bus was driven in irregular circles as shown in Figure 2-6 and finished each run by returning to its initial parked position. Physically, the bus had turned 720 degrees with respect to the original position and returned to its starting position. Through the circular driving, the accumulated errors were obtained and potential errors from other sources were cancelled. The tests were conducted at maximum speeds of 5 mph and 15 mph. The data analysis in Appendix B shows that after the bus completed a 720 degree turn, the error in the accumulated gyro yaw angle estimation was within 0.1% (Figure B-17 and Figure B-18) compared to the known accumulated angle change of 720 degrees.

Figure 2-6 - Verification of Gyro yaw rate accumulation error test

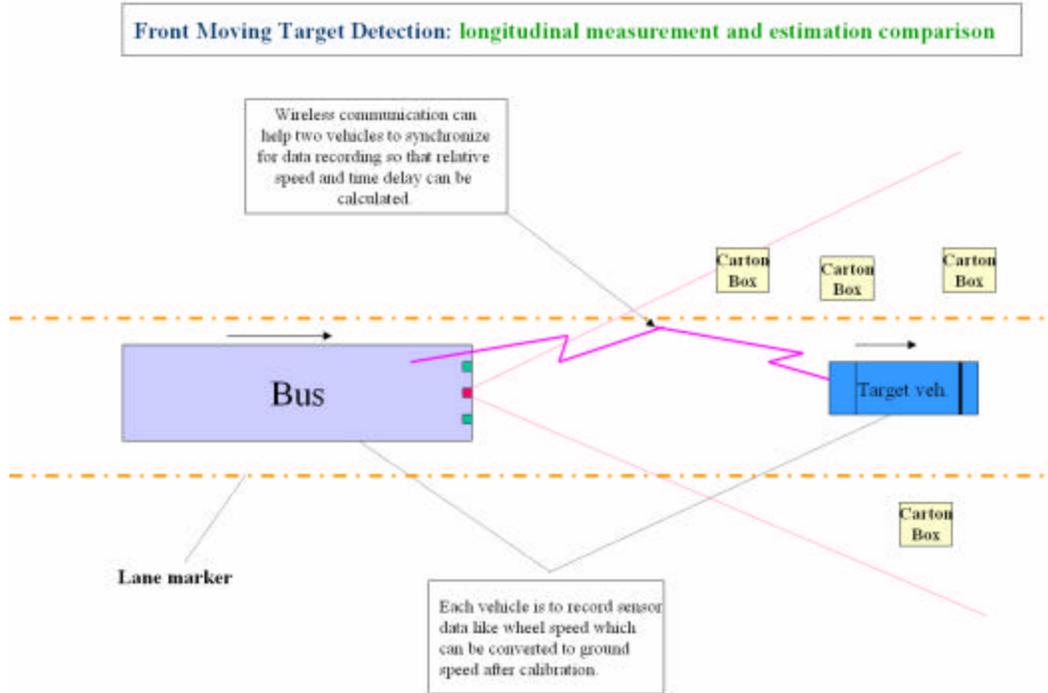
The setup involves a target vehicle equipped with fifth wheel, wireless communication between the host bus and target vehicle, and static targets located to the left and right of the vehicle path. Because the string pot was not connected, the bus could operate at much higher speeds, with higher relative speed and larger variations. During the tests, the target vehicle ran at constant speeds of 5 mph, 10 mph, 27 mph, 40 mph, or 50 mph. It was up to the bus driver to determine a safe and comfortable inter-vehicle distance compatible with vehicle speed and relative speed. The moving target vehicle accelerated or decelerated at rates of 0.2, 0.8, or 1.5 m/s^2 . The maximum relative speed recorded was 4.6 m/s or approximately 10 mph.

Figure 2-7 - Vehicle following, without use of string pot

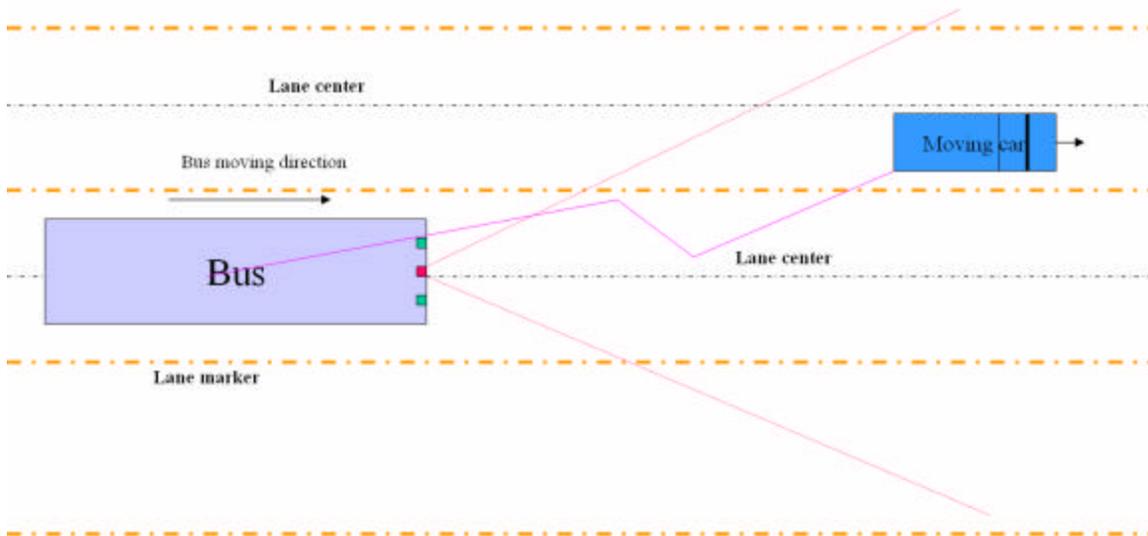
Moving target maneuver: Side Moving Car Detection with Known Lateral Position

Figure 2-8 - Moving target vehicle in adjacent lane

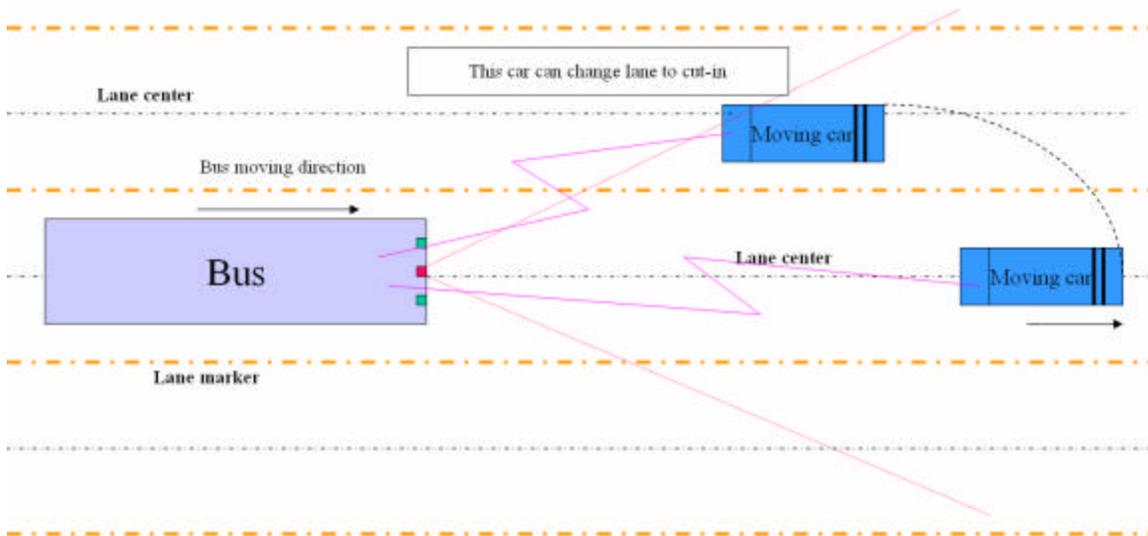
Cut-in & cut-out maneuver: lane change to cut-in

Figure 2-9 - Cut-in to test lateral movement detection

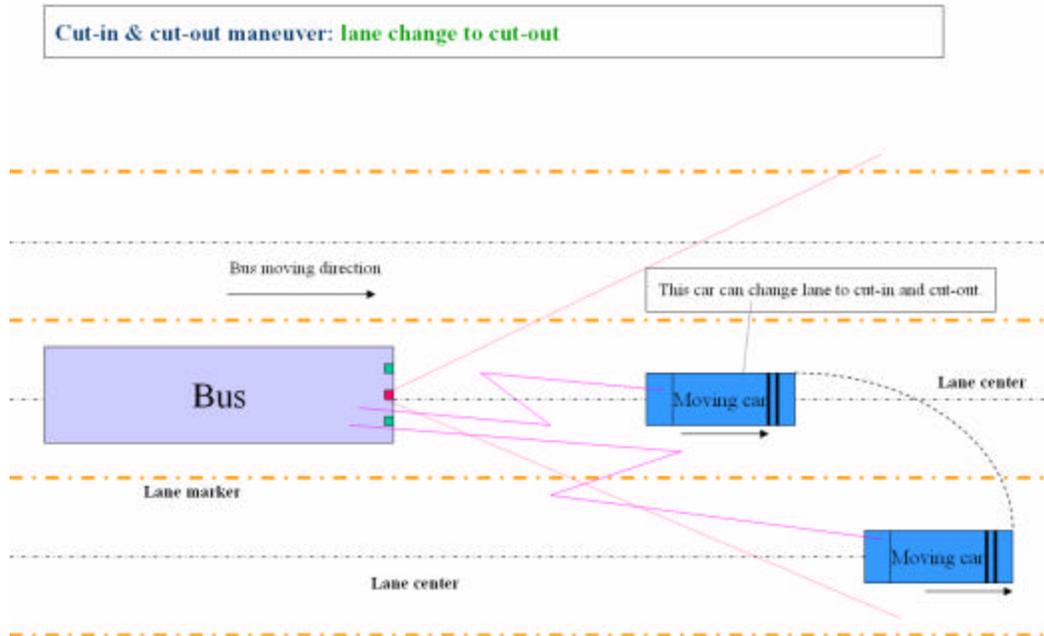
The detection of cut-in and cut-out maneuvers involves detection of vehicles in adjacent lanes (left/right), keeping a tracking record of those vehicles, and measuring and predicting their behavior based on previous and current information. Data analysis in the Appendix shows that track building starts when the inter-vehicle distance is about 5 m, while the target vehicle is still completely in the left lane early in the cut-in maneuver. The target track is dropped at about 7 m inter-vehicle distance after the target vehicle has completely moved out to the right lane for the cut-out maneuver. This detection is quite effective, fully tracking the cut-in and cut-out motions of the target vehicle. This is consistent with the LIDAR lateral measurement characteristics in the results obtained from the testing described in the sensor verification section.

Figure 2-10 - Cut-out to test lateral movement detection

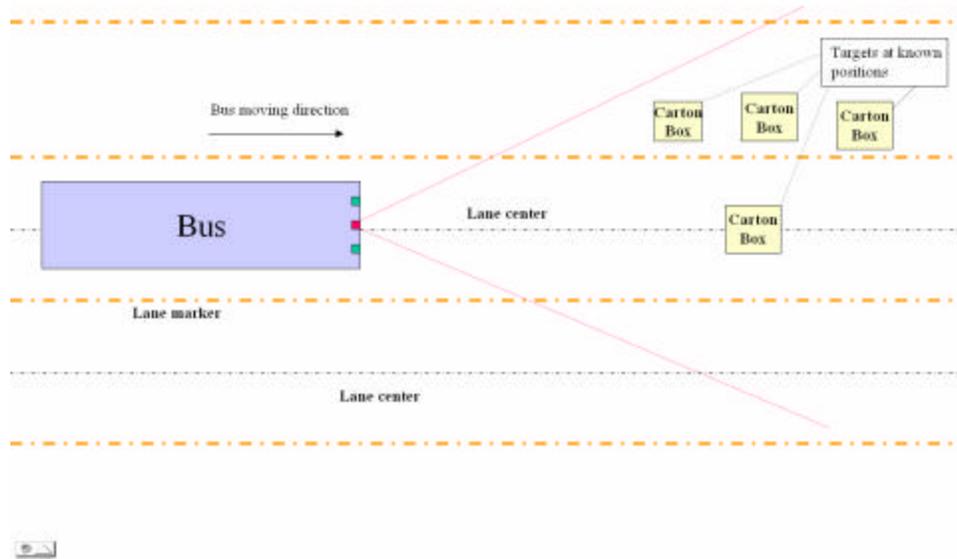
Crash and Detection Test: Static Objects with Known Positions

Figure 2-11 - Low Speed Crash Test

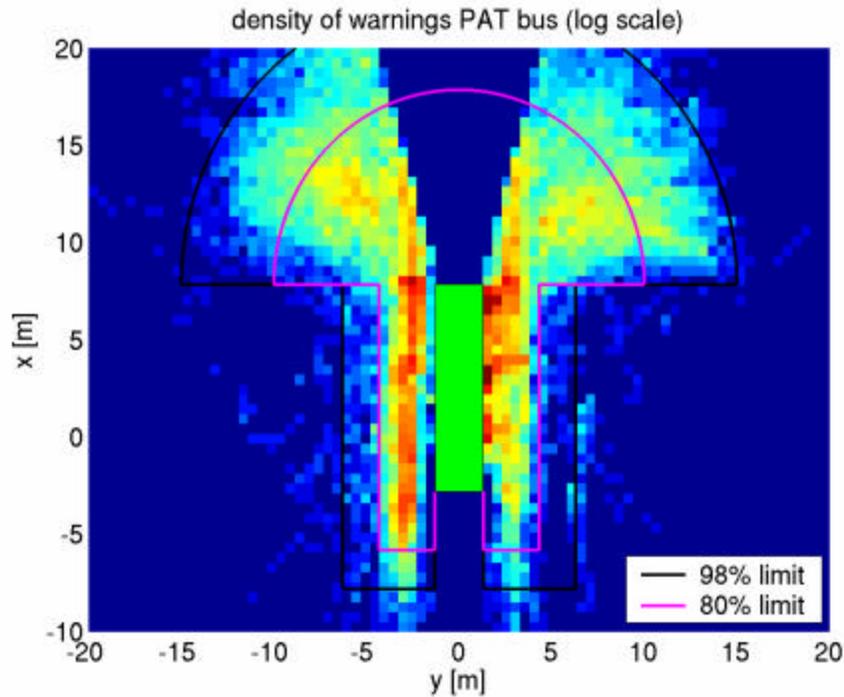
We wanted to determine the maximum range that the laser scanner needs to cover in order to detect all the dangerous situations the bus is exposed to during normal operations. For this we created a density plot of the location of all the warnings, based on the warnings from all good runs. The density plots for the SamTrans and the PAT buses are shown in Figure 2-13 **Error! Reference source not found.** and Figure 2-14 where the highest density is dark red and the lowest is dark blue.

Figure 2-13 - Density (log scale) of warnings around the PAT bus

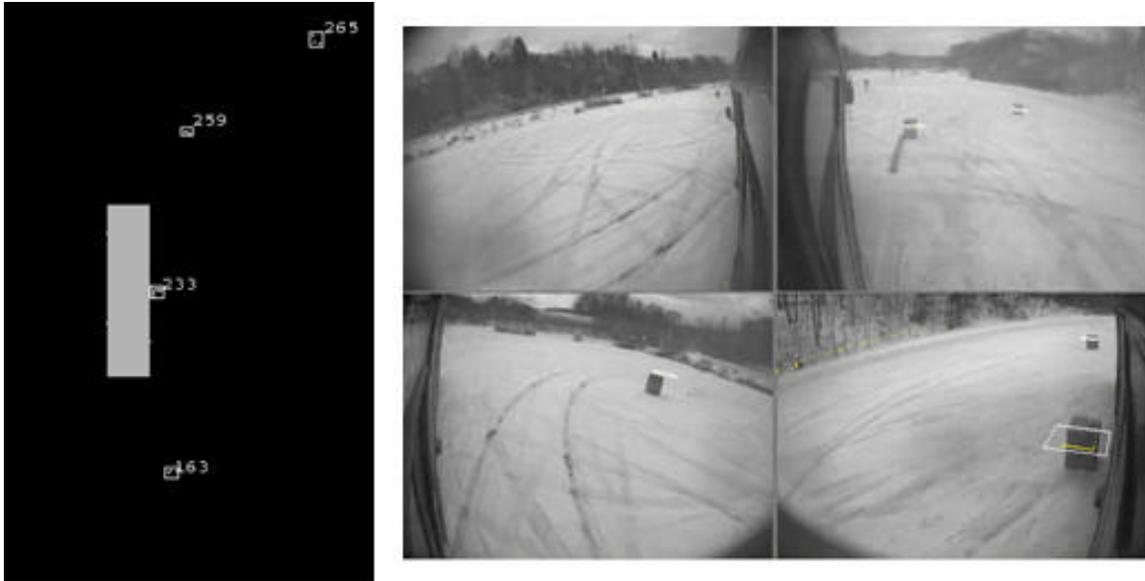
Figure 2-15 shows the first of the arrangements, with all boxes stationary. On the left is a birds-eye-view with the bus and the laser scanner data. On the right is the view from the four side cameras. The bus drove past the cardboard boxes, sometimes getting close to a collision and sometimes actually hitting them. In the second arrangement (

Figure 2-15 - Snapshot of the bus driving past four boxes

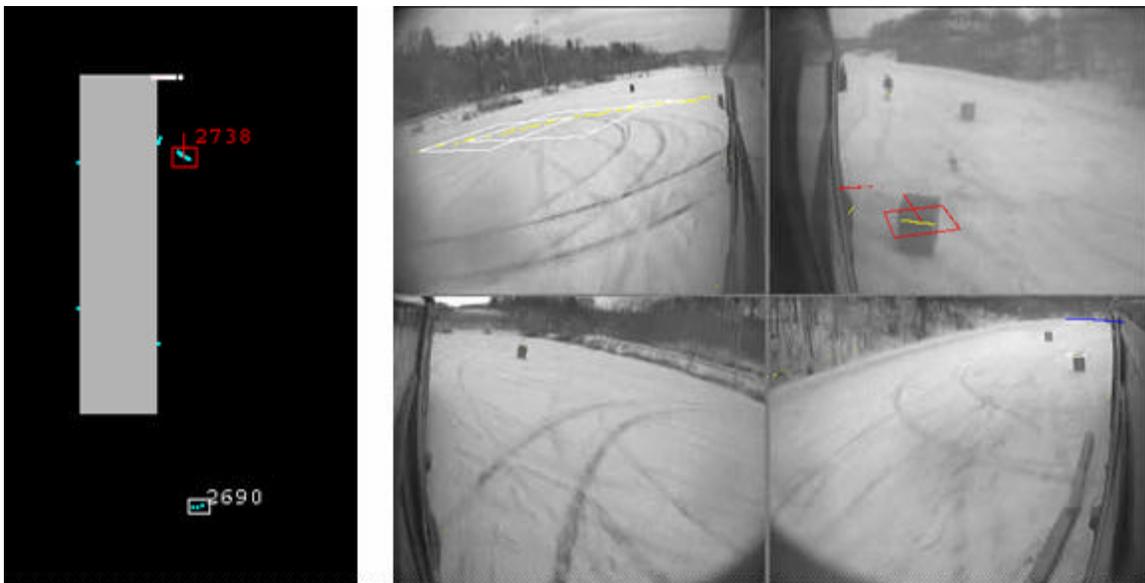
Figure 2-16) one of the boxes was pulled parallel to the initial driving direction of the bus while the bus is making a sharp right turn.

Figure 2-16 - One of the boxes is pulled parallel to the driving direction of the bus

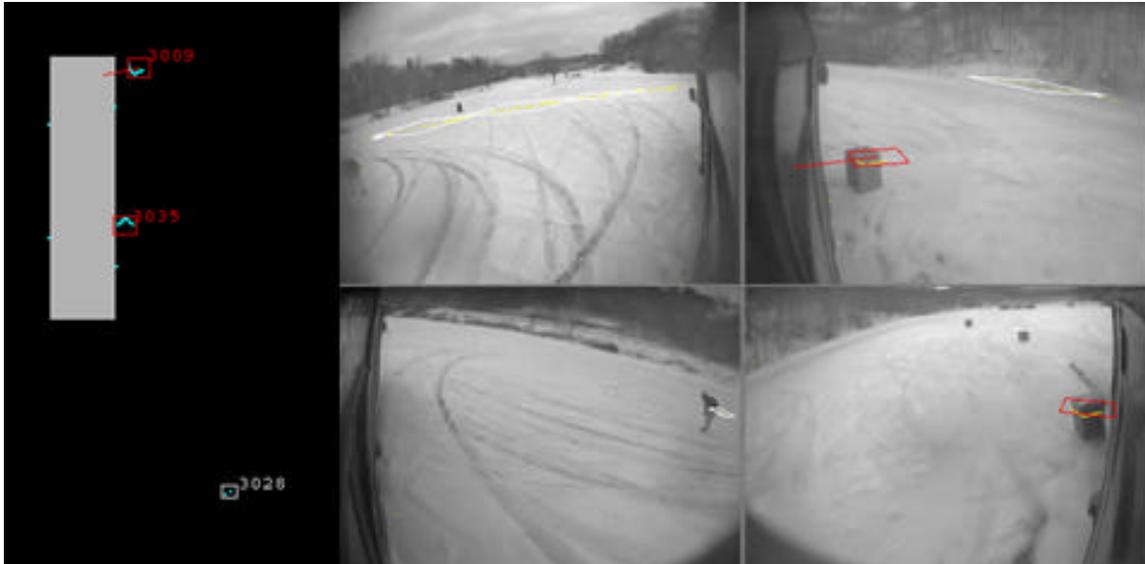
In the next arrangement one of the boxes is pulled perpendicular to the initial driving direction of the bus. In some instances the box collided with the side of the bus, as happened in the scenario shown in Figure 2-17, and sometimes the front of the bus hit the box.

Figure 2-17 - The box in the front is pulled perpendicular to the bus

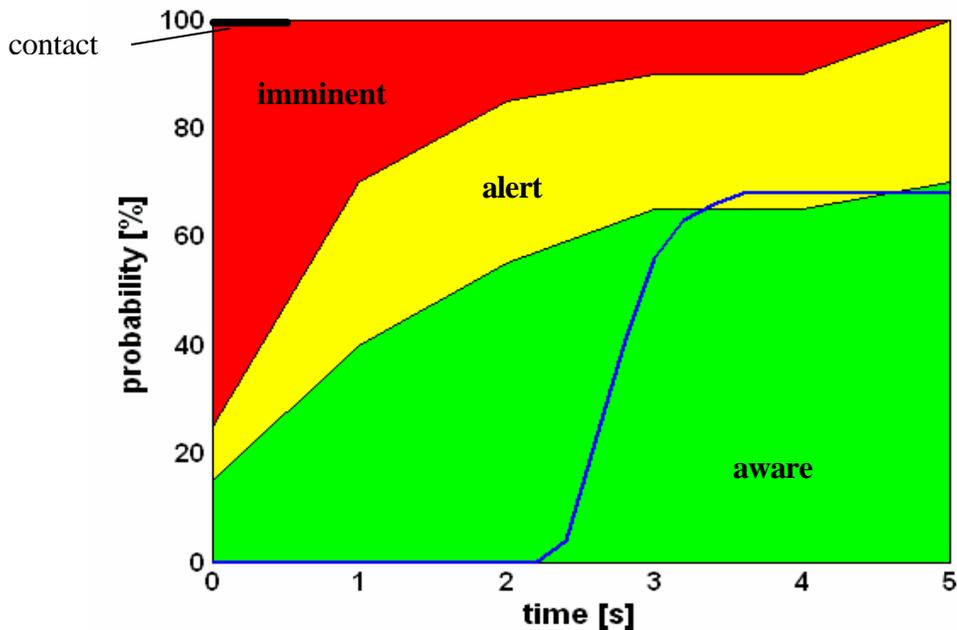
Figure 2-18 - The POC distribution of all curves of all objects from one run

The left plot in Figure 2-18 shows the accumulation (z-axis) of the POC (y-axis) vs. time (x-axis) plots for the entire test run, with a logarithmic z-scale. The right plot is a planar projection of the same data, with the colored fields representing the accumulated values. The limits for the 0.015 percentile (yellow line) and the 0.0005 percentile (red line) most dangerous situations are shown. We found that these boundaries for the “imminent warning” and “alert” areas of the POC graph gave the best results.

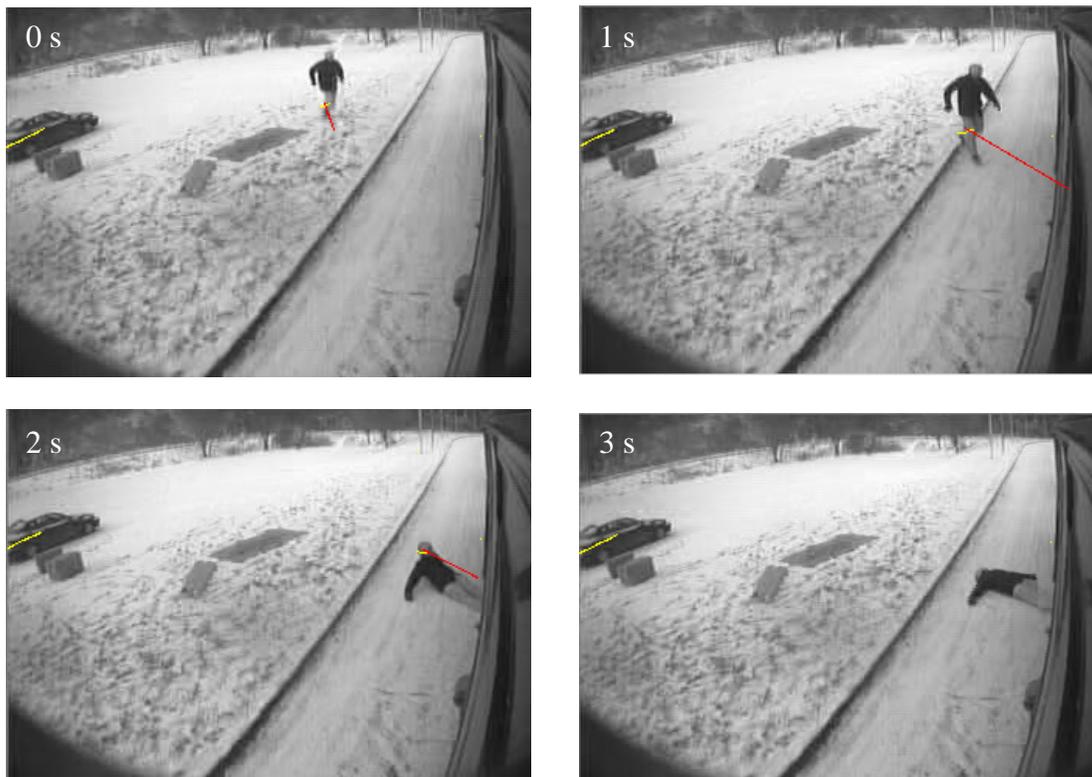
Figure 2-20 - A three-second image sequence of a person falling under the bus

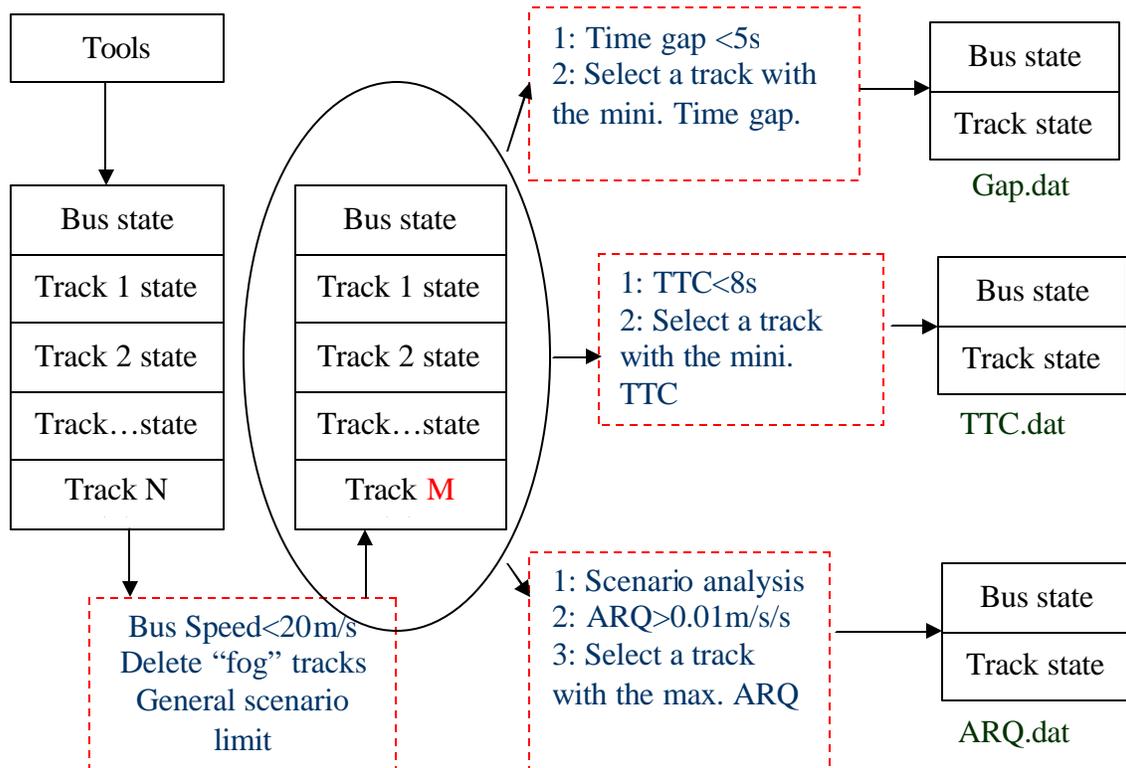
lateral distance to the chosen target is no greater than 2 meters. Lastly, the tracks are put into categories by sorting and are saved in different data files. For example, the time gap parameters of all tracks are calculated, those that meet the requirement of “time gap < 5 seconds” are selected and compared, the one track with the minimum time gap (the most significant time gap track) is then stored in a file Gap.dat along with the bus state.

Figure 3-1 - Data sorting procedure

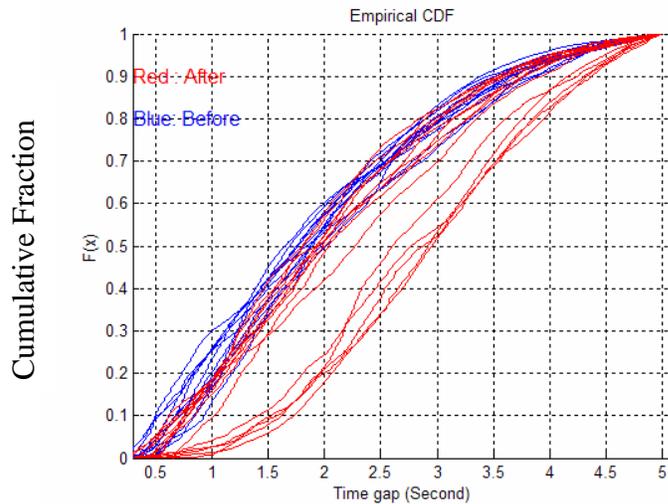
The cumulative distributions of time gap in Figure 3-2 through Figure 3-8 show a large diversity of car-following behavior and of responses to the activation of the DVI among the seven bus operators. Of these operators, operator F was the most aggressive by an appreciable margin, and he appeared to use the forward collision warning system to drive slightly more aggressively (perhaps pushing the limits to try to operate on the boundary of triggering alerts).

Figure 3-2 - Time gap cumulative distribution (Operator A)

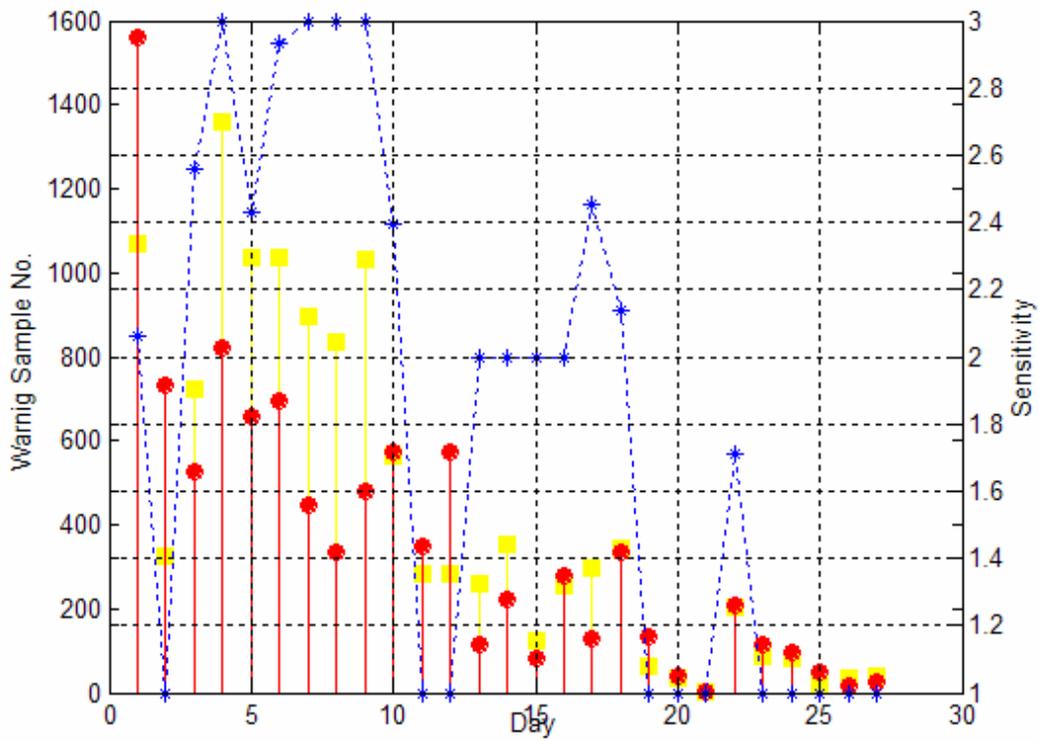
Figure 3-9 through Figure 3-11 also show variations between the imminent warnings and alerts received by the three different operators, with Operators B and C generally getting many more alerts than warnings, while Operator A received more of a mixture, with sometimes more warnings than alerts and sometimes more alerts than warnings. The variability of these results gives a strong indication of the importance of providing the operator with the flexibility to adjust the system sensitivity level. Even within the relatively homogeneous (compared to the driving population in general) set of these three operators, the need for the three sensitivity levels is evident from these results. Operator A gravitated toward the lowest sensitivity setting, leading to very infrequent alerts by the end of his period of driving the instrumented bus, while Operator B went in the opposite direction and Operator C was between the other two in preferences.

Figure 3-9 - Post-activation evolution of sensitivity versus warnings/alerts (Op A)

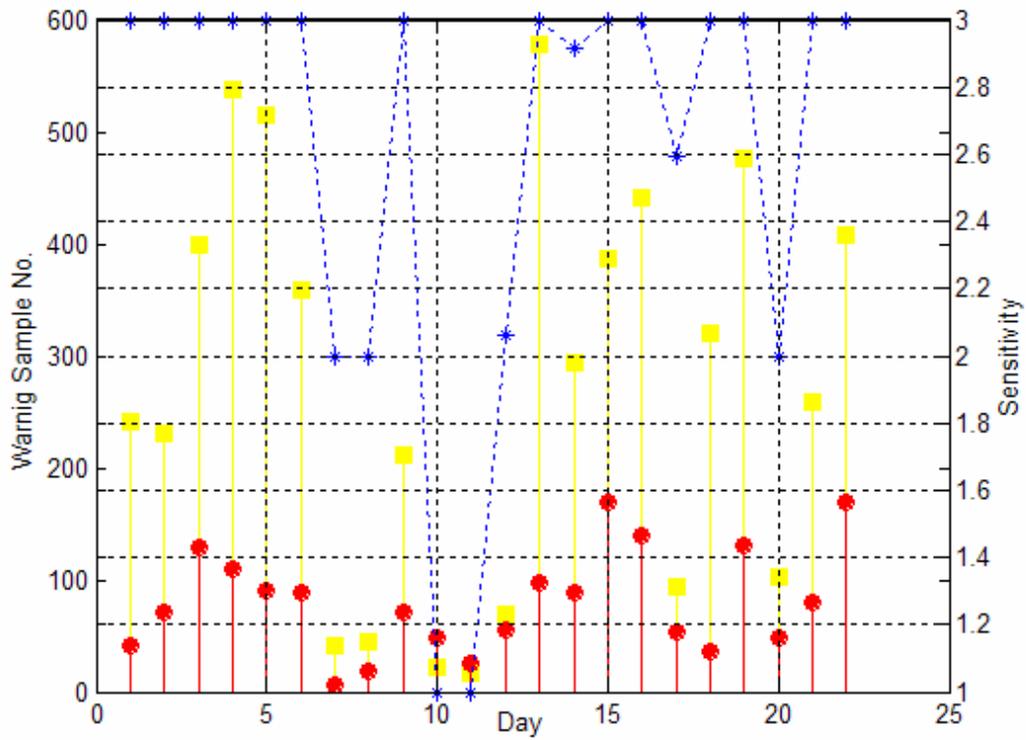
Figure 3-10 - Post-activation evolution of sensitivity versus warnings/alerts (Op B)

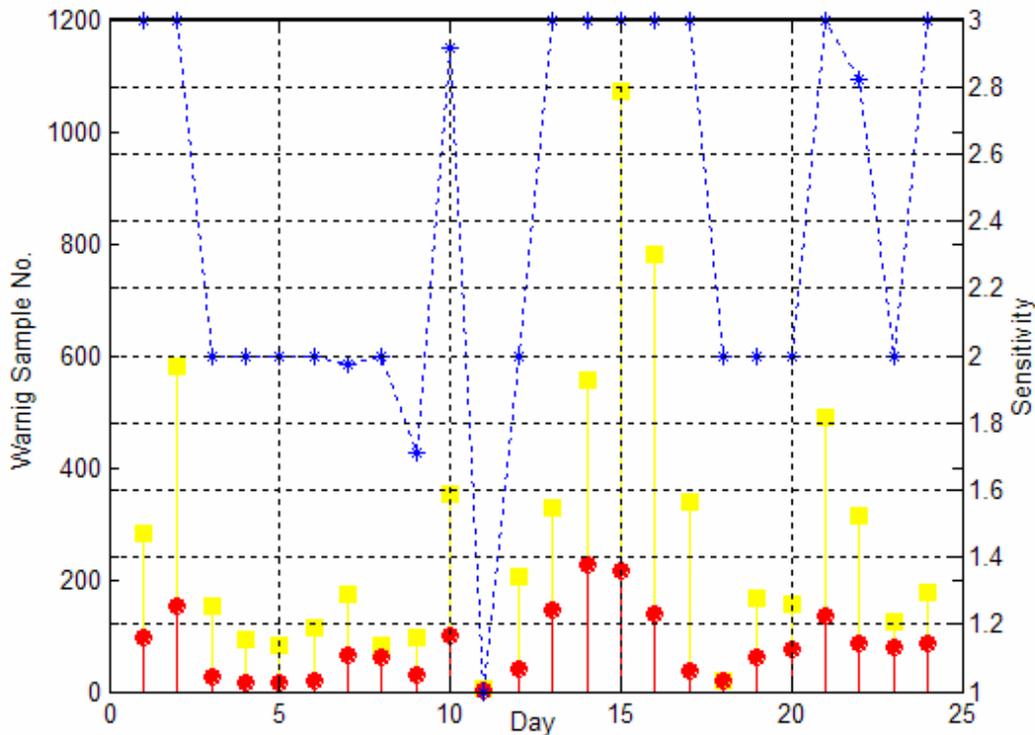
Figure 3-11 - Post-activation evolution of sensitivity versus warnings/alerts (Op C)

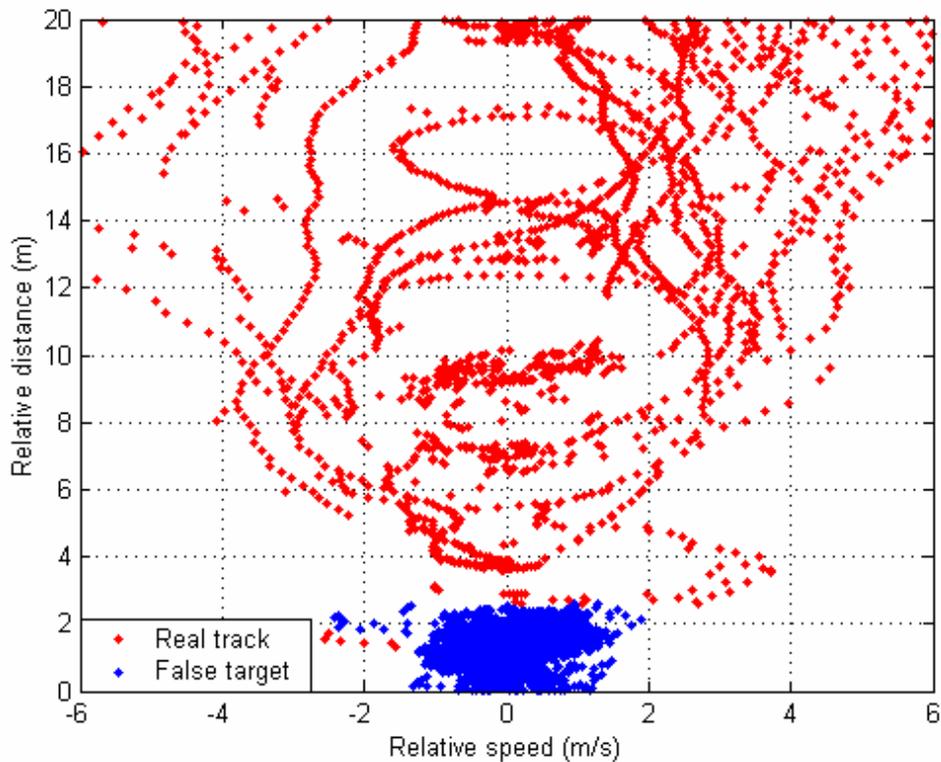
The SamTrans bus FCWS performance was studied under fog and rain conditions. During the initial testing of the ICWS in Pittsburgh, when the system was exposed to more severe weather conditions than those of the Bay Area, the LIDARs experienced more false detections. Subsequently, a subroutine was developed to match the pattern of the false targets and eliminate the target tracks that were believed to be attributable to fog and light rain and snow. Figure 3-12 shows the range-range rate plot of real targets (in red) and the false tracks caused by fog, rain and snow that are recognized by the algorithm subroutine (in blue) (12/10/2004). The improved algorithm rejects tracks that have a relative longitudinal distance to the bus of less than 1 meter, or around 2 meters but with a relative speed to the bus that is within (-2.6 m/s, +2.6 m/s) and have not been identified as vehicles.

Figure 3-12 - Range and range rate of target tracks and tracks rejected
