Integrated Collision Warning System
Final Evaluation Report (May 2006)
FTA-PA-26-7006-06.1

**Integrated Collision Warning System
Final Evaluation Report**

May 30, 2006

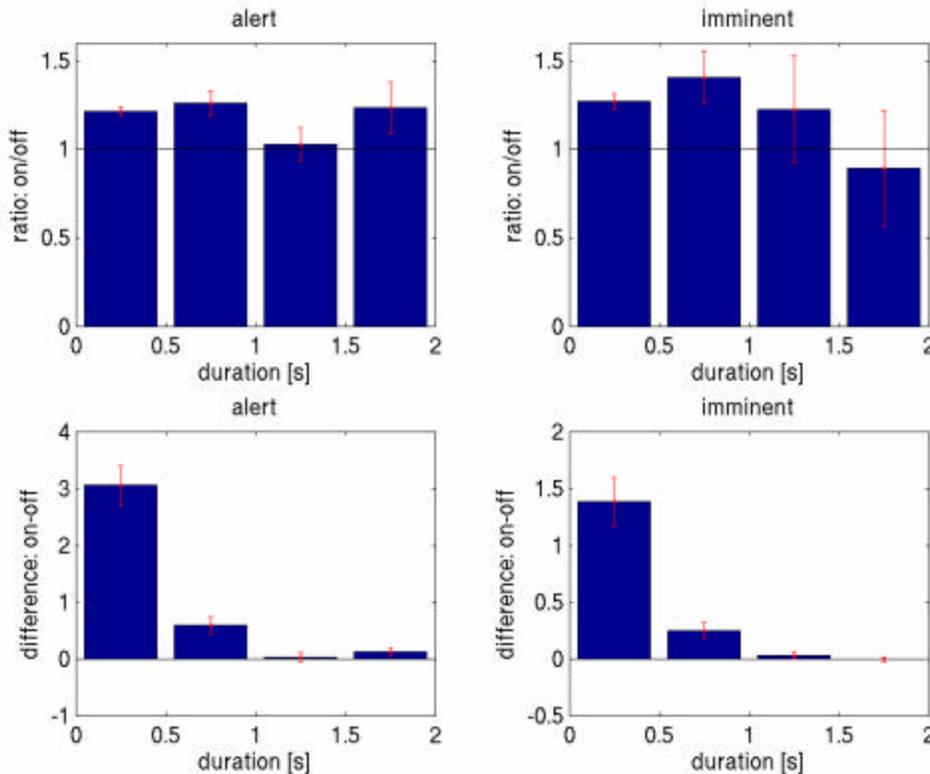
We did the calculations separately for the SamTrans and PAT data, but did not find a significant difference between the two data sets. The results agreed with each other within their statistical errors. We therefore combined both data sets to get a larger data sample. The conclusions are valid for both. Figure 3-14 shows the ratios and differences for the right side of the bus.

Figure 3-14 - Ratios/differences of the alert/imminent warning rates for the right side

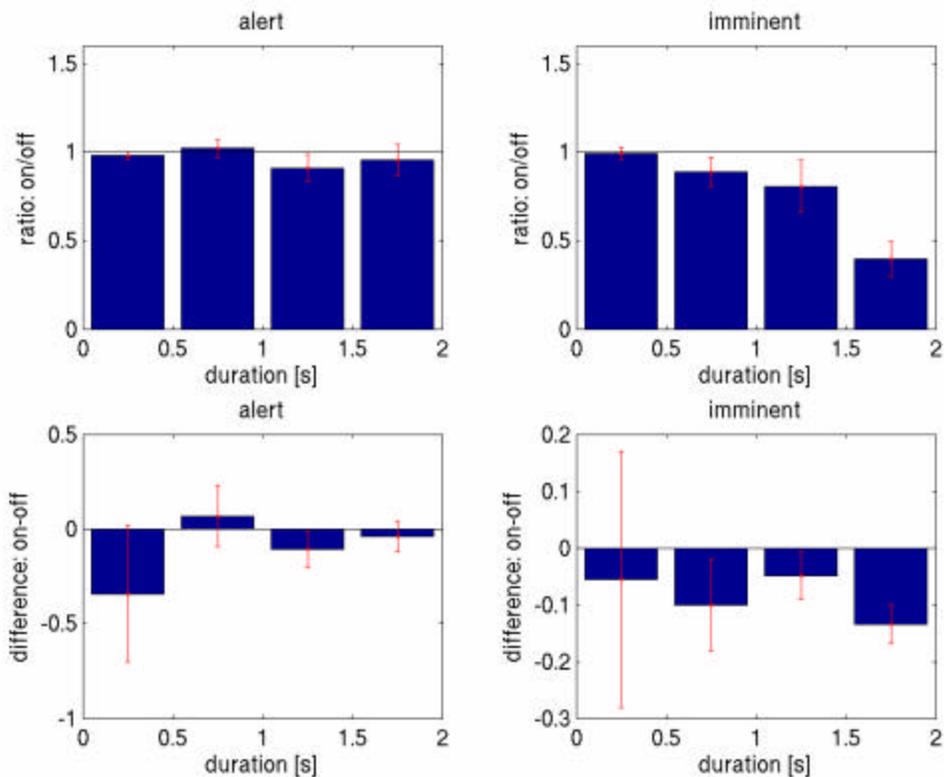
Figure 3-15 shows the ratios and differences for the left side of the bus:

Figure 3-15 - Ratios/differences of the alert/imminent warning rates for the left side

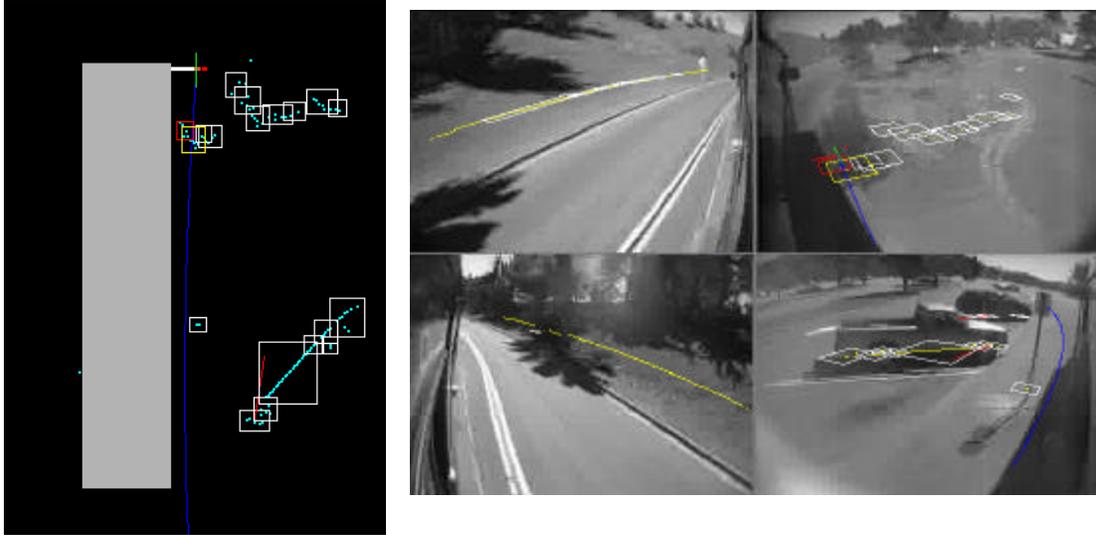
Figure 3-19 - Overhanging bush is close enough to trigger an imminent warning

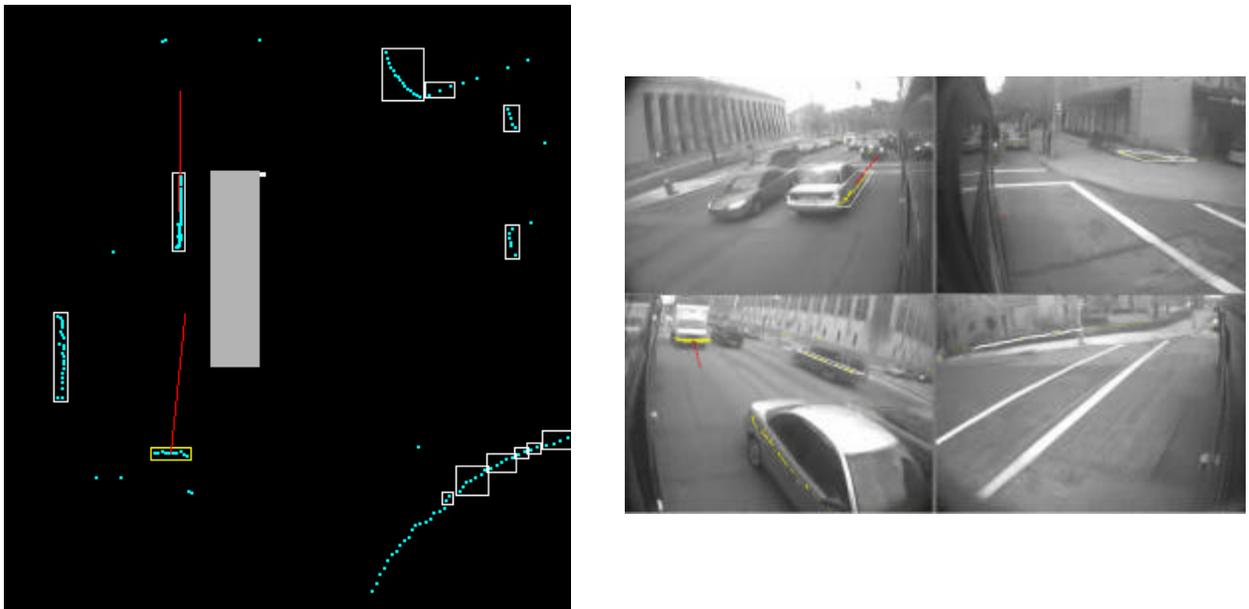
The distribution is characterized by a Gaussian shape plus some additional outliers. The false velocities which give false warnings are from the tail of the Gaussian distribution or are outliers. An example of a case when a slightly incorrect velocity leads to an alert is shown in Figure 3-20. The vehicle can be seen in the lower left image with a yellow box on it, indicating an alert. The yellow box also appears in the birds-eye-view display.

Figure 3-20 - The velocity of the vehicle is slightly off, leading to an alert

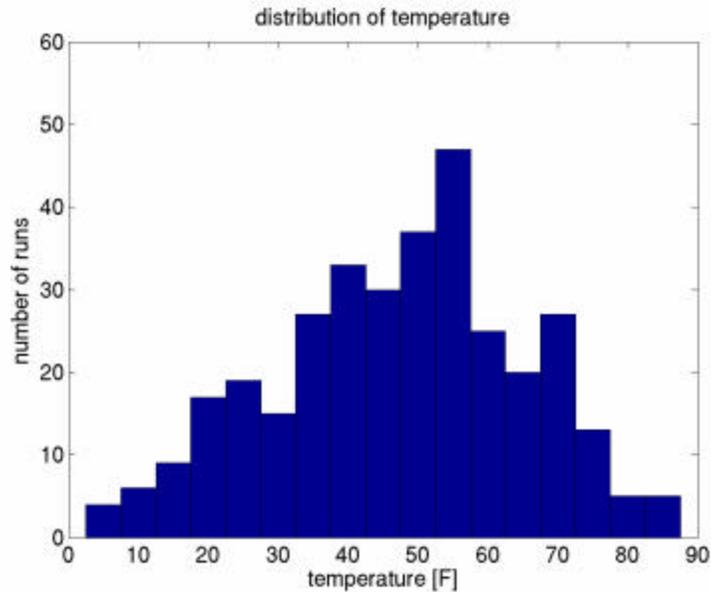
The distribution of average temperatures can be seen in Figure 3-23. The lowest temperature during a run was 3° F and the highest 85° F. The mean temperature for all runs was 47° F and the mode of the distribution was 55° F.

Figure 3-23 - Distribution of average daily temperature

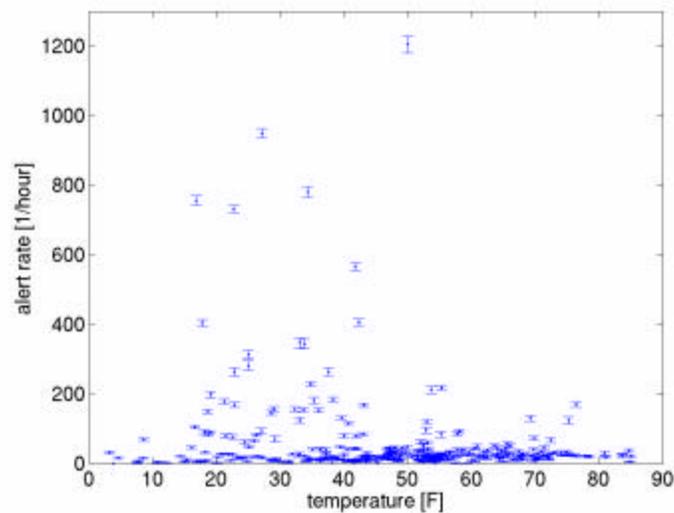
Figure 3-26 - Alert rate versus temperature

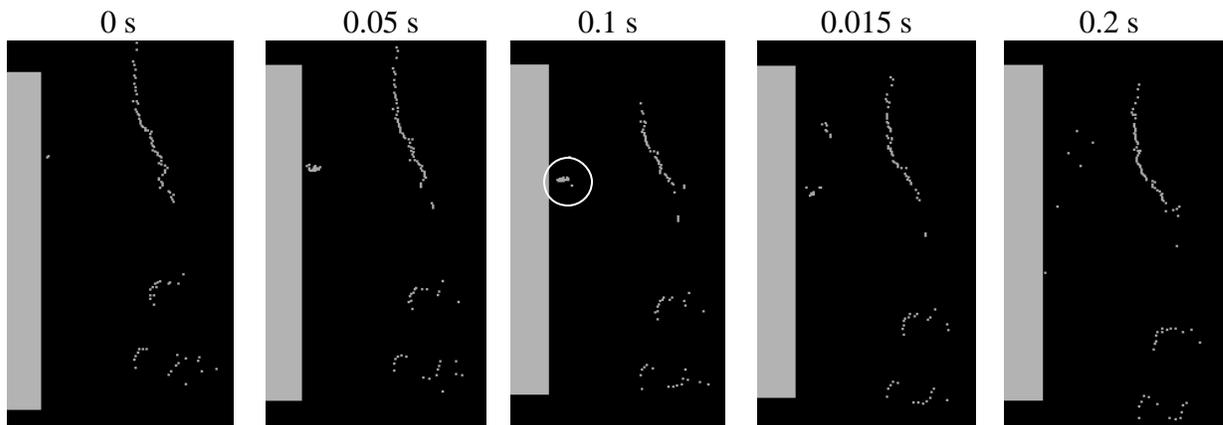
Water splashes from the front tires can be so strong that they appear as objects very close to the bus. These objects often trigger a warning and because they are so close to the laser scanner the retraction is also triggered. In Figure 3-27 one can see the development of such a splash, indicated by a circle in the middle image. The outline of the bus is on the left in grey.

Figure 3-27 - Example of a splash of water appearing on the right side of the bus

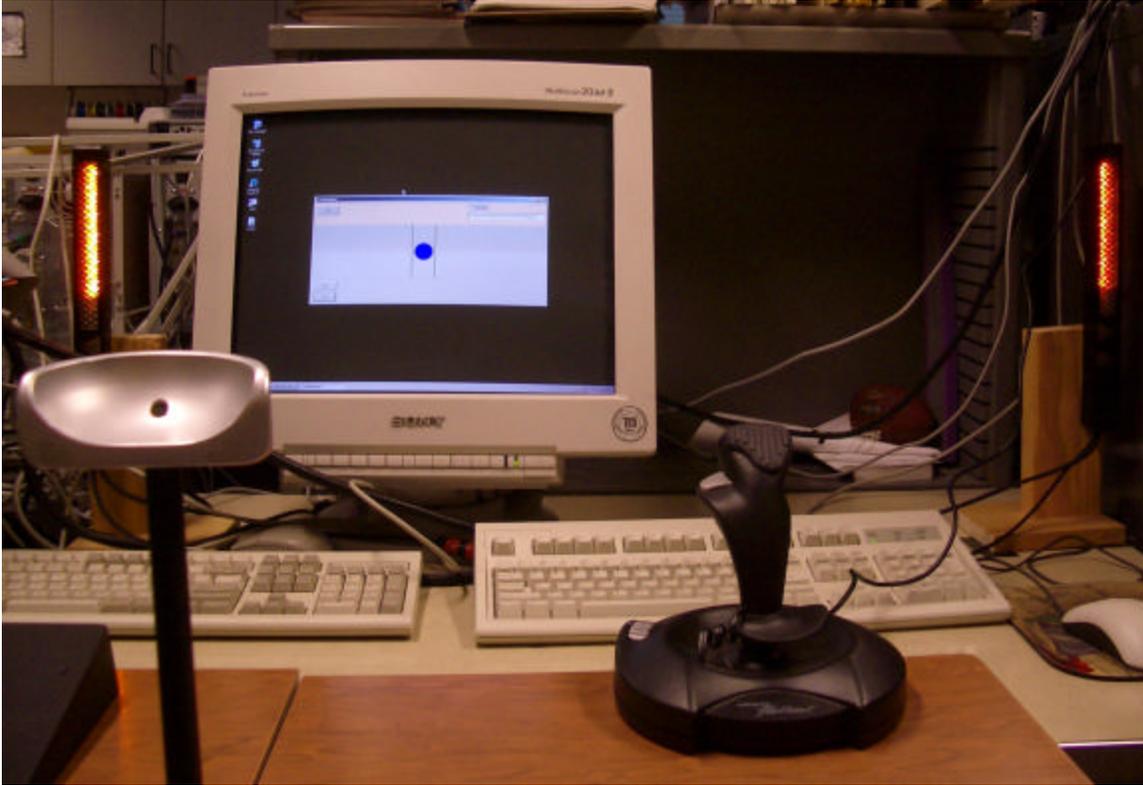
Figure A-2 - Set-up for DVI experiment

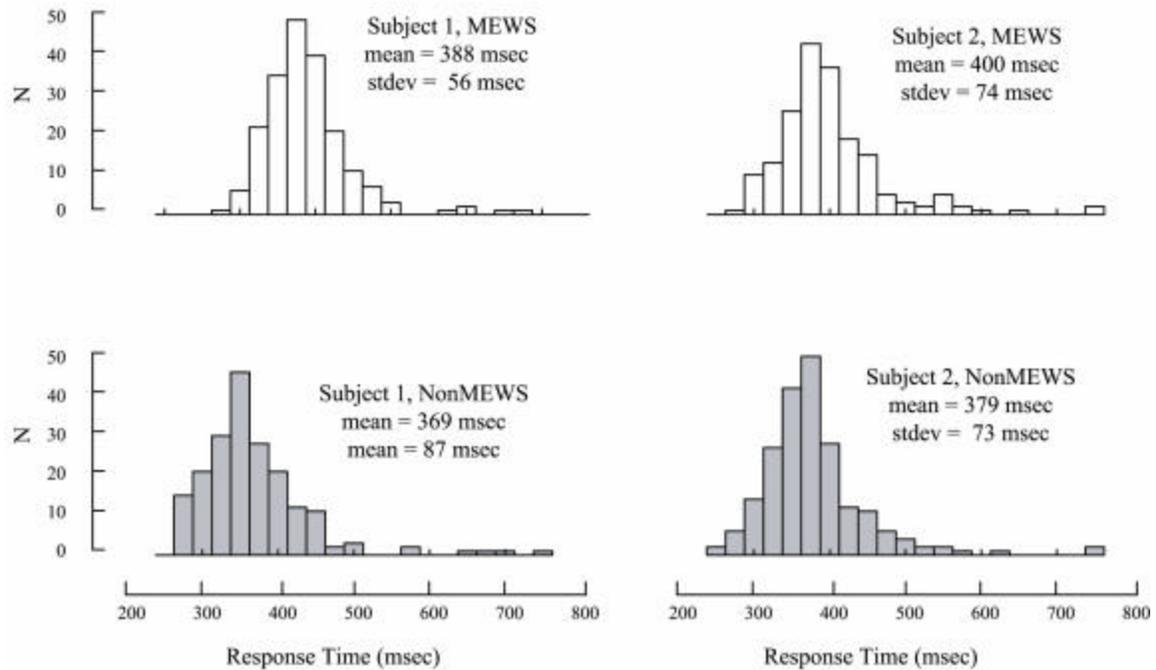
Figure A-3 - Histograms of response time to a high intensity signal (20 msec step)

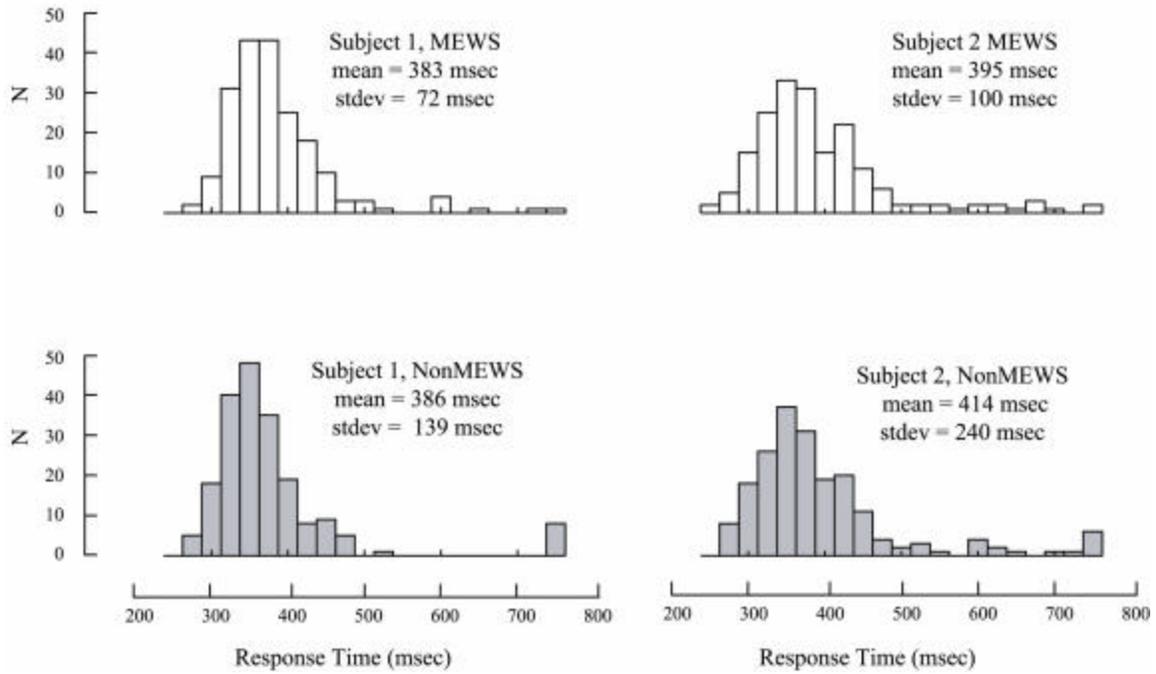
Figure A-5 - Histograms of response times to a low intensity signal (10 msec step)

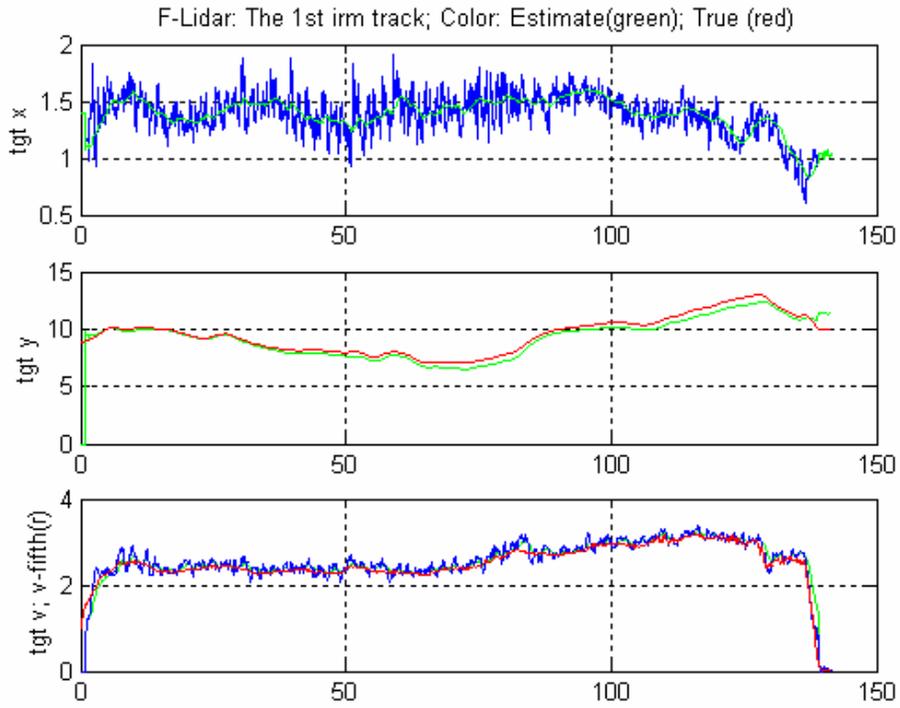
Figure B-1 - Lateral and longitudinal position and relative speed for Scenario 2

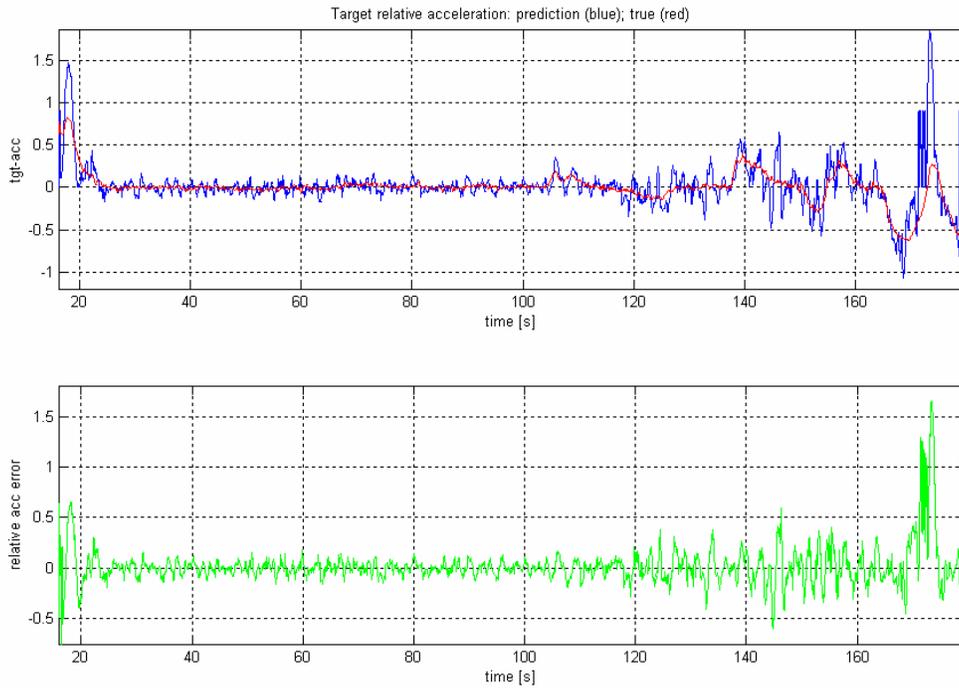
Figure B-4 - Front moving target absolute acceleration error

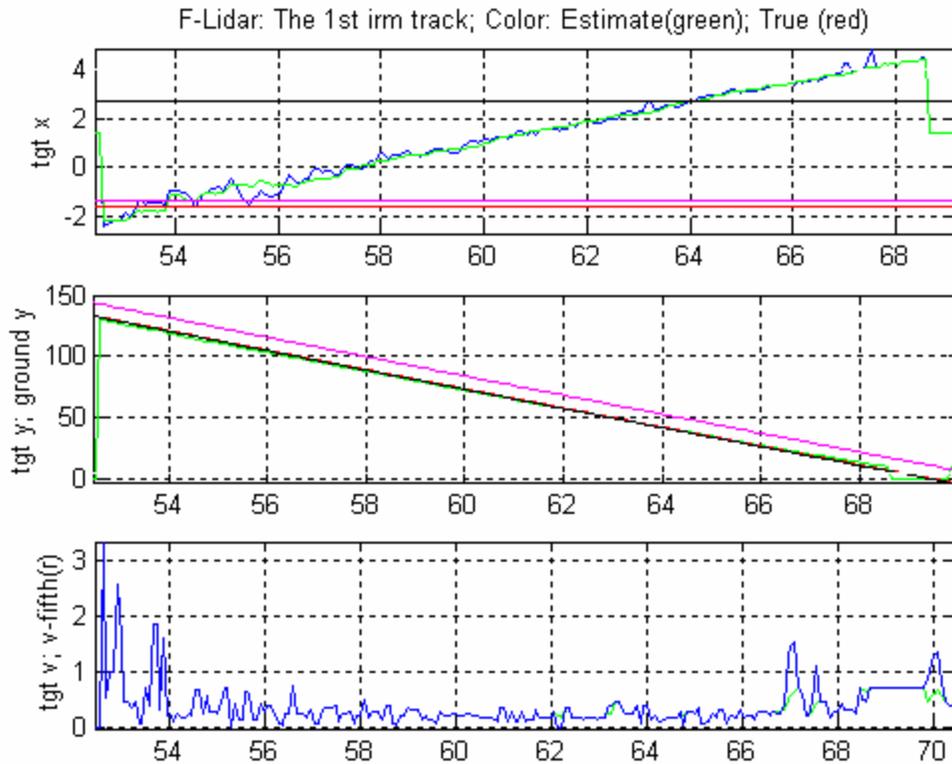
Figure B-5 - Lateral, longitudinal and speed estimation/prediction of first firm track

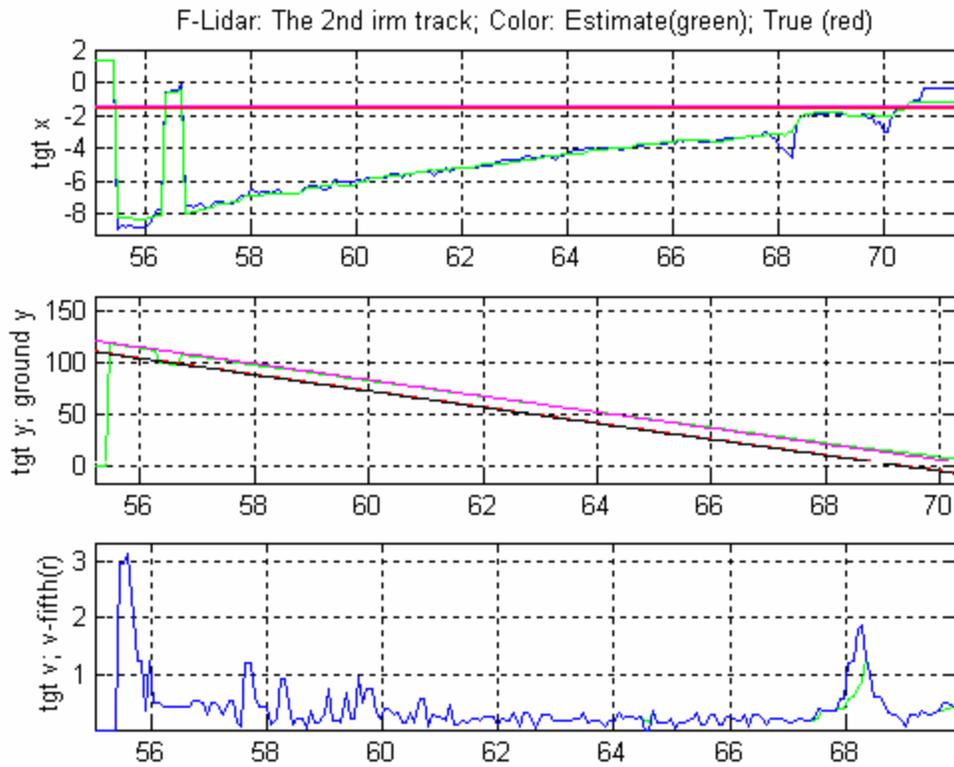
Figure B-7 - Lateral, longitudinal and speed est / prediction of second firm track

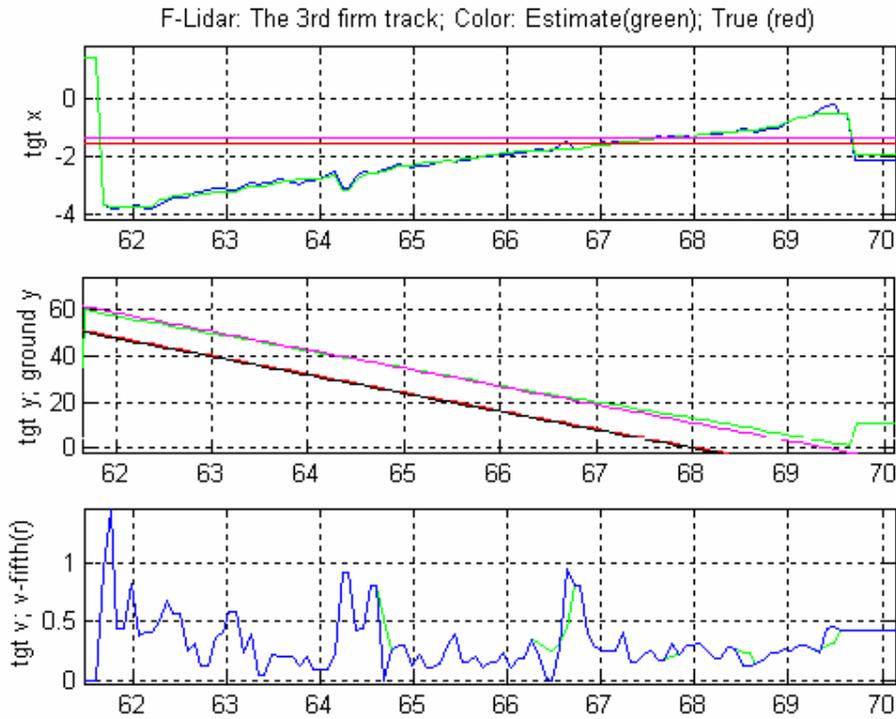
Figure B-9 - Lateral, longitudinal and speed estimation/prediction of third firm track

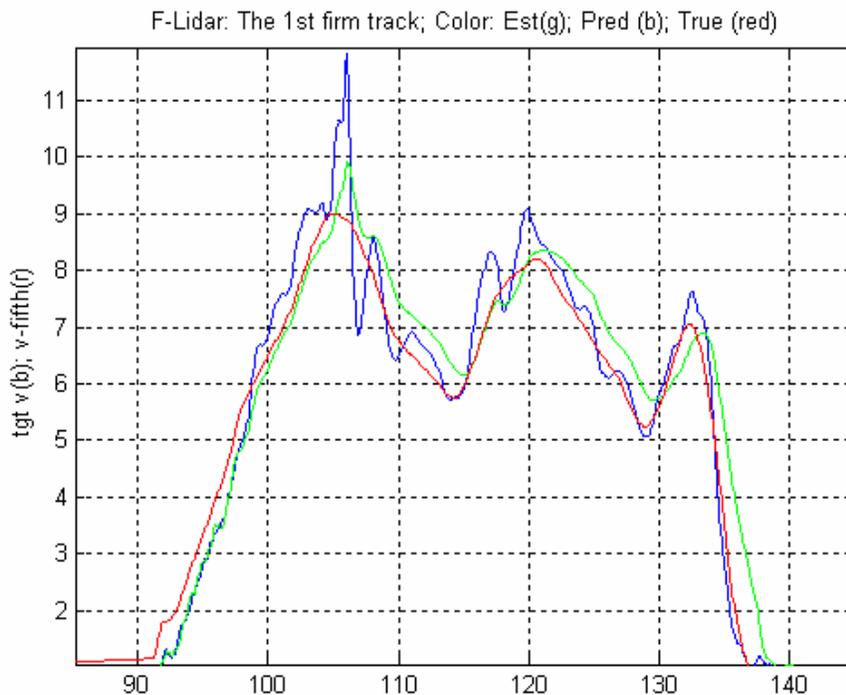
Figure B-11 - Target speed: fifth wheel (red), estimation (green) and prediction (blue)

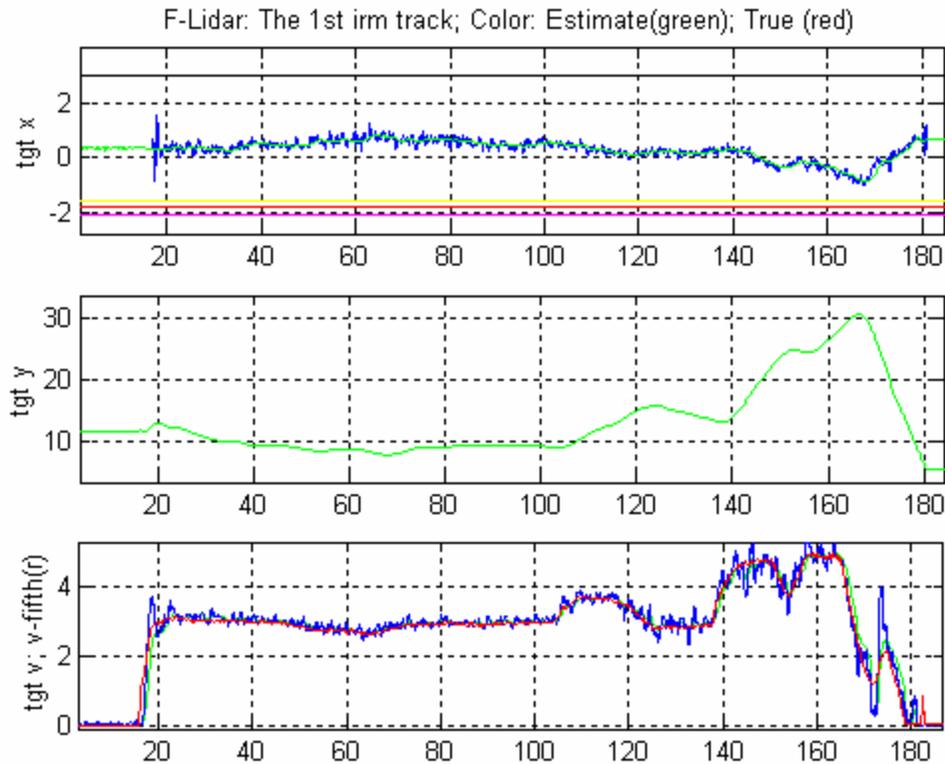
Figure B-19 - Lateral position, longitudinal relative distance and speed for Scen 1

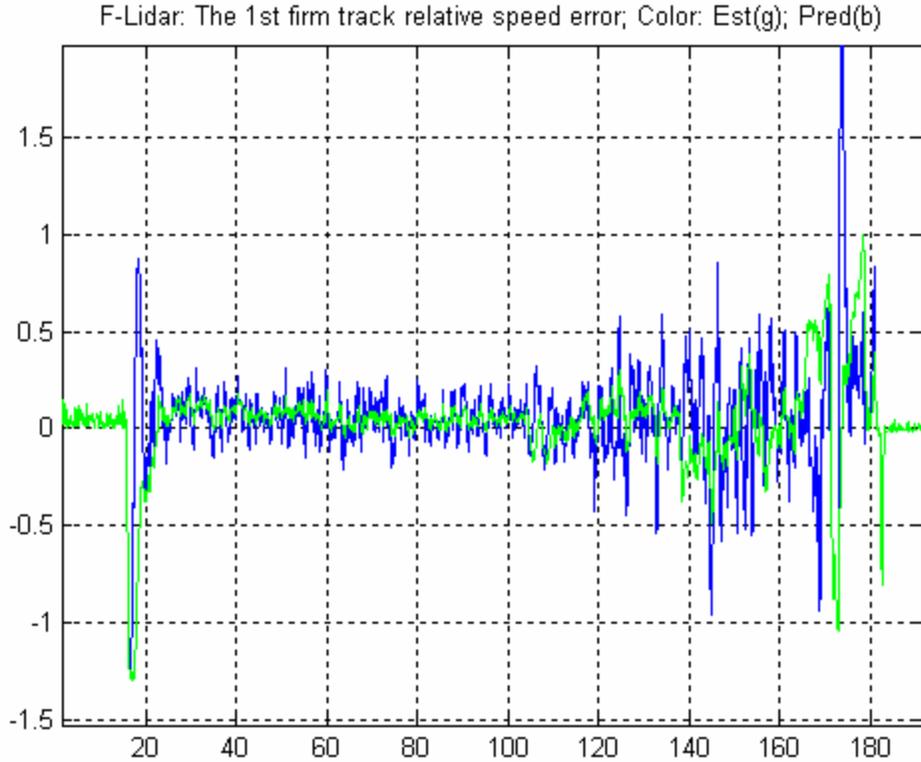
Figure B-20 - Relative speed tracking error wrt the fifth wheel of the target vehicle

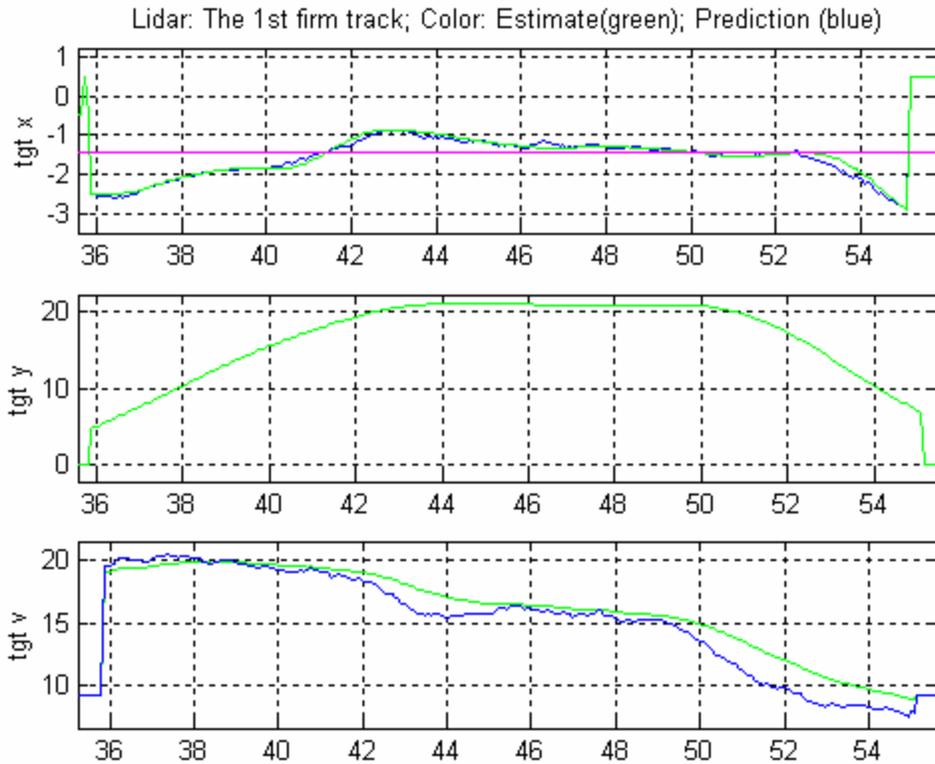
Figure B-26 - Left adjacent lane moving target (vehicle) detection

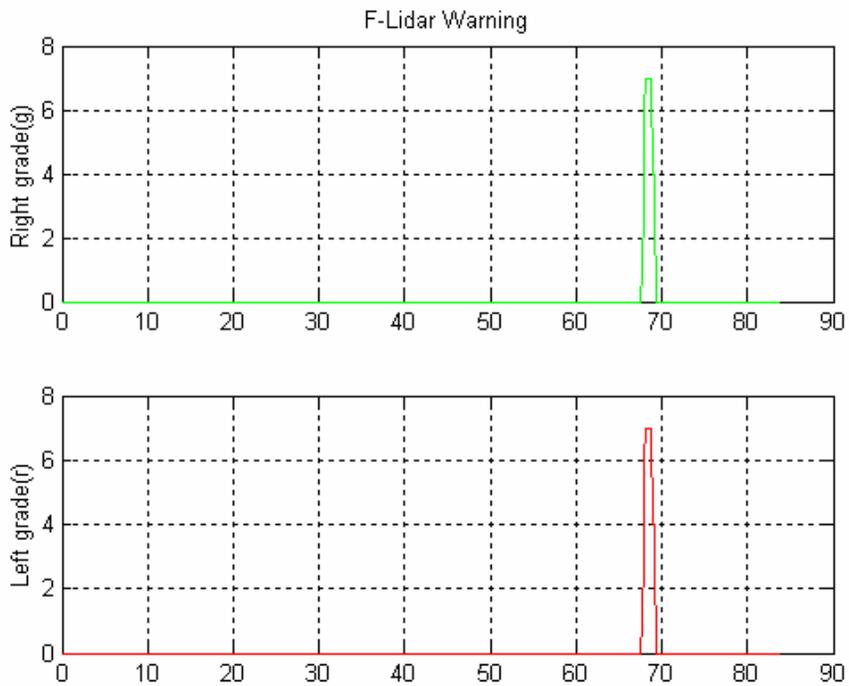
Figure B-29 - Low-Speed Crash Test, Left and Right Warning Levels

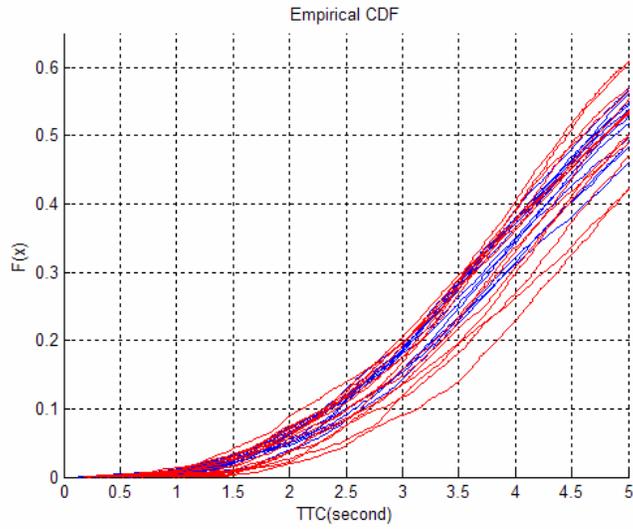
Figure C-14 - Time to Collision Cumulative Distribution (Operator A)
